# Internal Erosion in a Full-Scale Experimental Embankment Dam: Insights from the Dismantling of the Älvkarleby Test Dam

## Abstract

# 1 Introduction

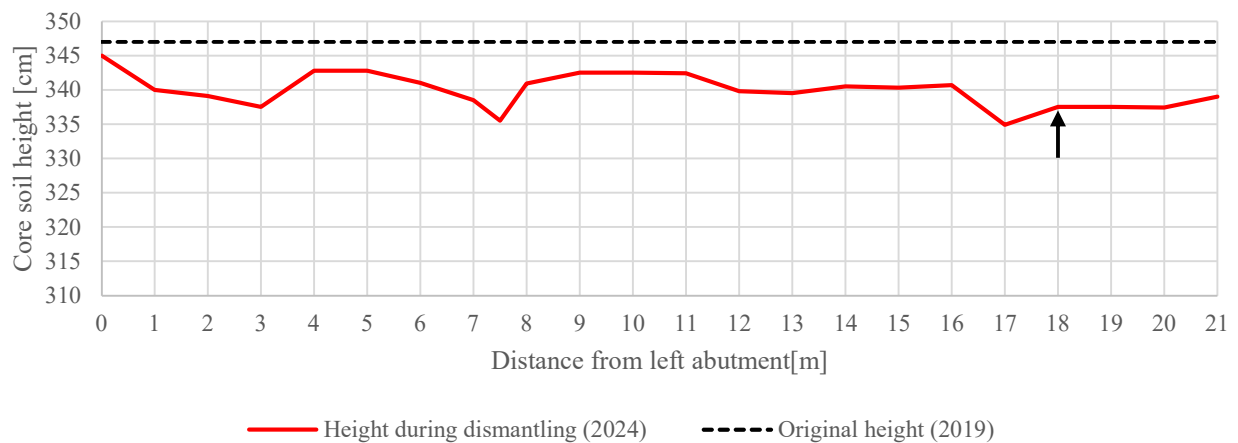
*Settlements* in the dam body were observed during dismantling. The core crest had differential settlements up to 10 cm, see Figure 5. At time of construction in 2019, the height of the core soil was at 347 cm with a tolerance of  $\pm 5$  mm. No settlements were seen before dismantling, except at one inclinometer in the downstream rockfill slope. Several laser scanning campaigns were done 2019 – 2024. The laser scans had a resolution of about 1 mm.

Figure 5. Core soil height at time of dismantling, (Lagerlund and Riaz 2026). Piezometer section marked with black arrow.

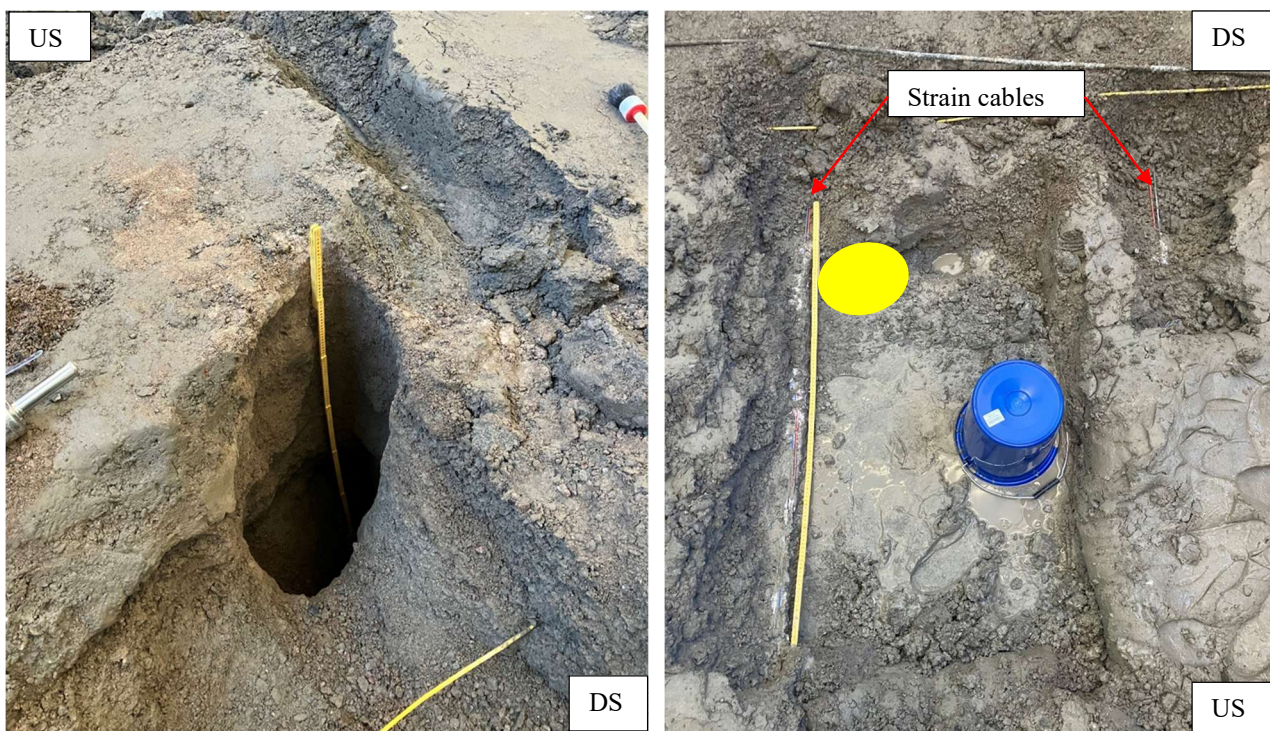
A *developing sinkhole-like feature* (about 300 litres in volume) was found between levels 1.4–0.2 m above the base, approximately 17.5 m from the left abutment, see Figure 7. The feature was filled with eroded core material, with finer particles concentrated in the upper portion and coarser material at the bottom, see Figure 8. Beneath the sinkhole, at approximately 0.2 m above the base, a very wet and softened zone was encountered, approximately 1 m wide. This area was located between two of the four pre-stressed strain cables installed horizontally through the core at 0.15 m height with a one meter spacing.

Figure 7. To the left: sinkhole-like feature with its eroded core soil material removed. To the right: Wet, damaged core soil beneath the sinkhole-like feature. Bottom of the sinkhole-like feature marked with a yellow circle, (Lagerlund and Riaz, 2026).

The saturated and softened condition of the soil beneath the sinkhole, observed during dismantling, aligns with these findings. The problem in this area was not high pore pressure, but a local loss of strength caused by erosion and water flow reducing the stress. These observations reinforce the importance of careful design and sealing of embedded elements,

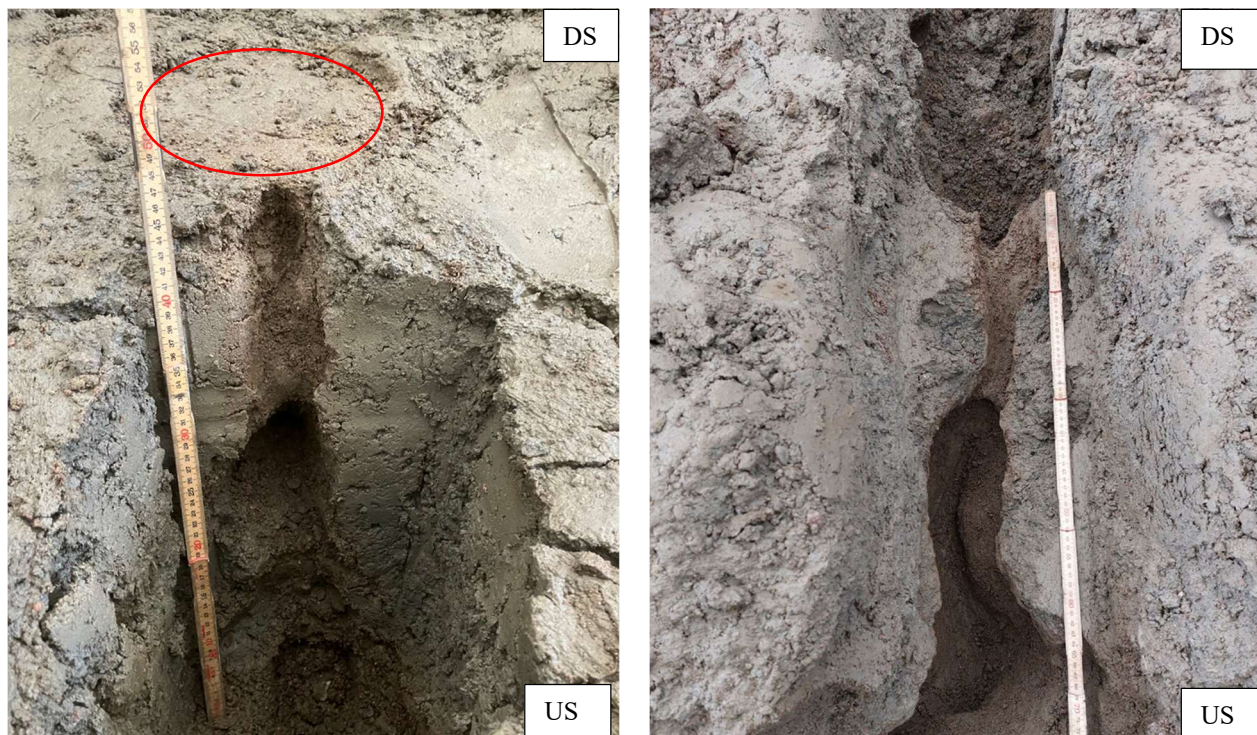
Three horizontal erosion pipes were observed underneath the base of the vertical coarse column defect. These were located along horizontal layer boundaries and contained coarse sand and fine gravel, see Figure 9. In addition, signs of erosion were also observed at the top of the vertical defect, near the crest of the core soil.

Figure 9. To the left: Erosion at three different levels under the vertical defect (red circle). To the right: The core soil “roof” of the middle pipe removed. After the eroded soil was removed, the damage had the shape of an hourglass with the waist located ca 20 cm below the bottom of the vertical defect, (Lagerlund and Riaz, 2026).

The vertical coarse column defect exhibited erosion at both its top (at the core crest) and base (at level 1 m), with three horizontal erosion pipes extending along core soil layer boundaries (Figure 9). These layer boundaries, which are weak because they don't bond well (Fell and Fry, 2007), likely helped water move sideways once it entered the vertical defect. The bidirectional erosion pattern implies that the defect acted as a conduit under varying hydraulic gradients (Toromanović *et al.*, 2025).

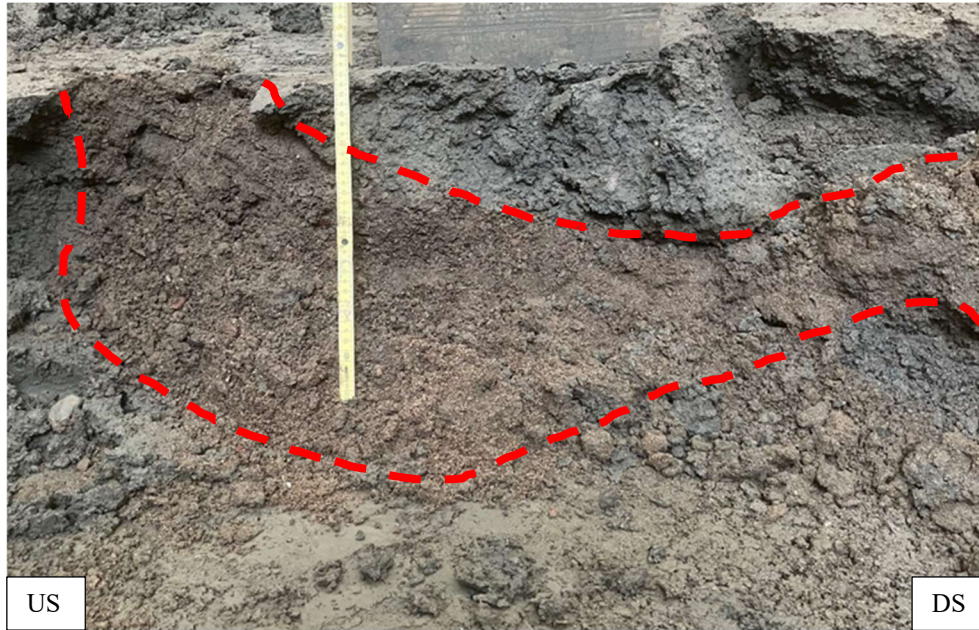
A sandy zone (~1 m long, ~40 cm high) was found near the wooden block defect at level ~1 m, starting at the core–downstream fine filter interface but did not traverse the core soil completely, see Figure 10.

Figure 10. Eroded core soil found close to the wooden cube (between red, dashed lines). The material was coarser on the downstream side than on the upstream side, (Lagerlund and Riaz, 2026).

Additional erosion features, including a sandy zone near the wooden cube defect (Figure 10) and thin erosion streaks along core layer boundaries (Figure 12), further demonstrate the role of localised discontinuities. Although the sandy zone was located in proximity to the wooden cube, there was no physical connection between the two, and the wooden cube cannot be considered a contributing factor in its formation. The orientation of the sandy zone, sloping toward the downstream fine filter, suggests a localised hydraulic gradient or material discontinuity as the more plausible cause. The erosion streaks, particularly in the lower core, align with horizontal construction layers and suggest early-stage internal erosion.

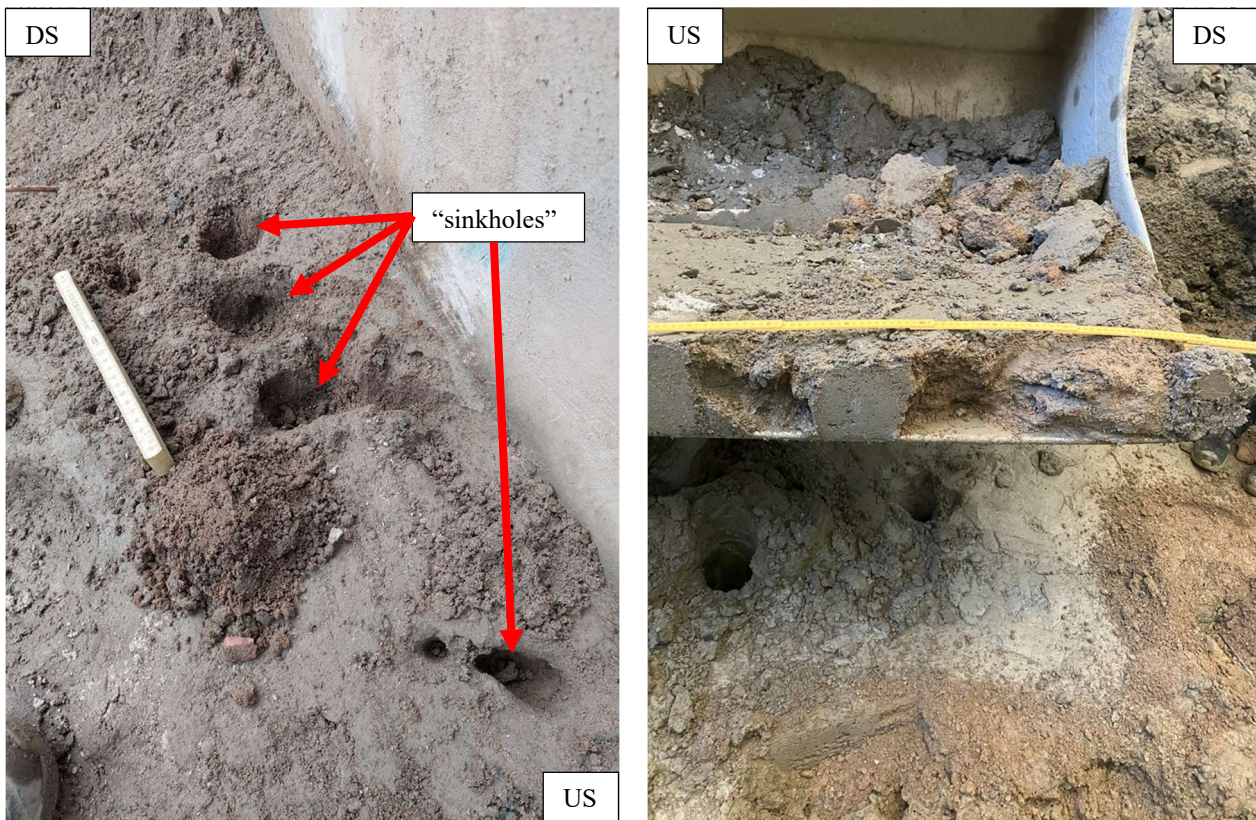
Along the right abutment, a zone of disturbed material was observed at a level of 0.5 m in the core, adjacent to the concrete wall. This zone extended across approximately one-third of the core's width, starting from the downstream fine filter, see Figure 11. Core soil from this area had lower content of fines, while the adjacent downstream fine filter had an elevated content of fines.

Figure 11. To the left: Sinkhole-like features found at the abutment marked with red arrows, eroded core soil material removed. To the right: A part of the abutment has been removed by the excavator and eroded core soil removed so the damage could be seen, (Lagerlund and Riaz, 2026).

At the right abutment, multiple small sinkholes and fines depletion in the core, coupled with fines accumulation in the adjacent downstream fine filter (Figure 11), indicate internal erosion along the core–structure contact. Achieving a perfect seal between compacted core and a rigid concrete abutment is known to be challenging, even with bentonite mastic applied (Fell and Fry, 2007; Lowe, 1997). In contrast, at the left abutment no signs of internal erosion were observed, underscoring inherent local variability in an ostensibly homogeneous dam, i.e., despite identical construction at both abutments, subtle differences can result in one side eroding while the other remains stable. By the time of dismantling (after ~4.5 years), the right-abutment erosion had propagated roughly one-third into the downstream portion of the core—a snapshot of the process, not an indication that progression was complete. Therefore, rather than a universal “constrained flow” artifact of the test setup, we interpret the right-abutment erosion as a localized phenomenon triggered by a specific vulnerability at that interface. It offers a cautionary insight that even when abutment contacts are built to standard, minor imperfections can lead to localized internal erosion, although factors like scale and boundary conditions should be considered when extrapolating to full-scale dams.

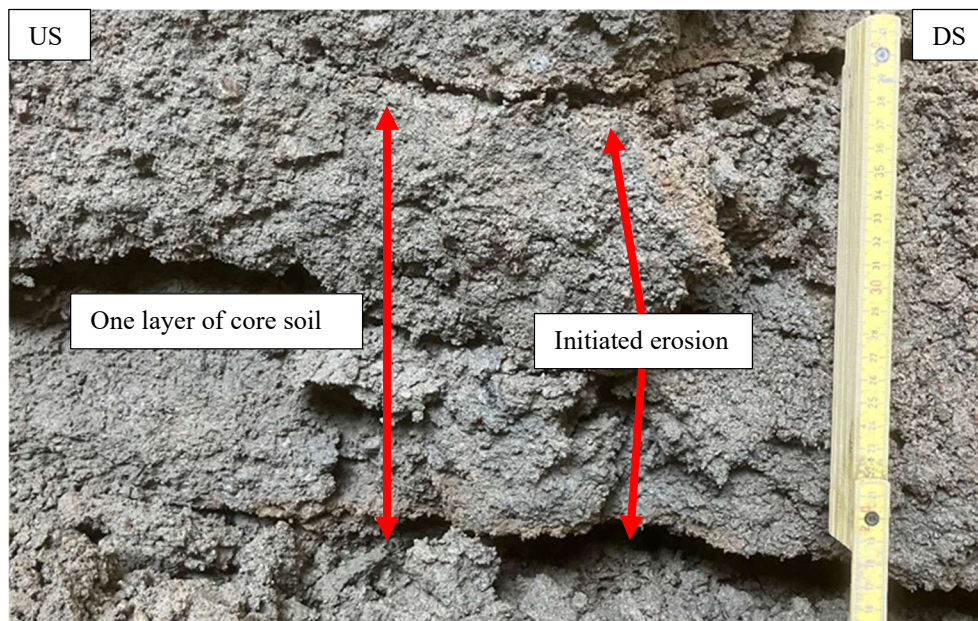
*Thin streaks filled with sand* were seen between core soil layers, especially near the downstream side, see Figure 12. These early signs of erosion were found in several places in the lower third of the core. In one case, when a block of core soil was turned over, a thin layer of sand was found underneath, showing erosion along the layer boundary.

Figure 12. Internal erosion, at a very early stage, found in the layer boundaries between the core soil layers close to the downstream fine filter, (Lagerlund and Riaz, 2026)

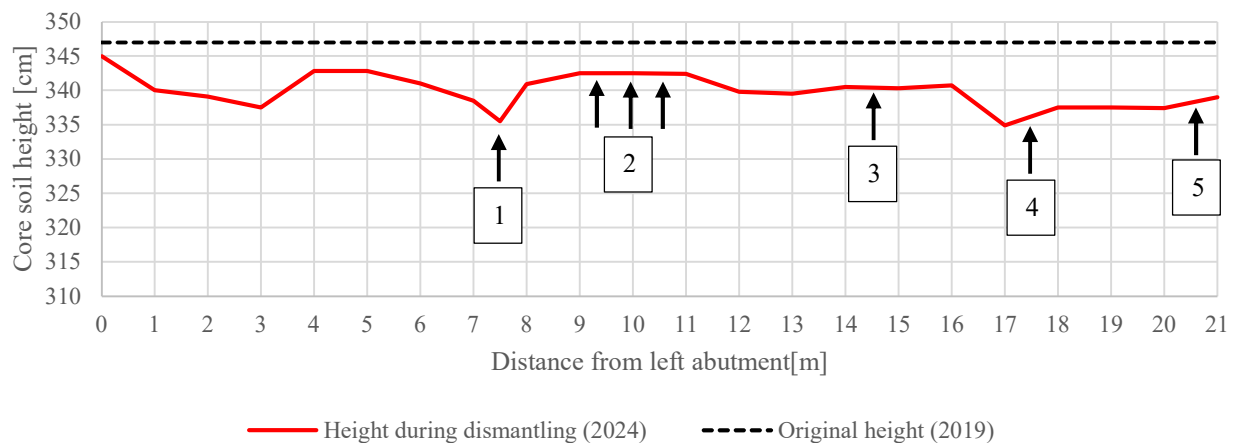
Figure 15. Settlements of the core crest with found erosion features highlighted, i.e., (1) three horizontal erosion pipes underneath the installed vertical defects, (2) thin streaks filled with sand were seen between core soil layers, (3) sandy zone, (4) developing sinkhole-like feature, and (5) zone of disturbed material at right abutment.

The most pronounced displacements occurred where the three horizontal erosion pipes underneath the installed vertical defects (Figure 9) were found and where the sinkhole-like feature and horizontally installed strain cables were located (Figure 7 right). These strain cables, even though sealed with bentonite, likely made compaction harder and created weak spots where water could flow more easily. Similar effects of embedded elements on internal erosion susceptibility have been noted in previous studies, e.g., Fell and Fry (2007), Foster *et al.* (2000). Pore pressure monitoring during both initial impoundment and during the five controlled reservoir drawdown-refill cycles revealed anomalous behaviour in this zone. During the first impoundment it took ~1 year for the pore pressures to build up (Toromanović *et al.*, 2022b). During the drawdown-refill, the bottommost downstream piezometer in the core soil on the downstream side of the core exhibited a significant and persistent drop in pore pressure following the second fluctuation. The values did not return to the levels they had before (Toromanović *et al.*, 2025). This was interpreted as evidence of a developing preferential seepage path or internal erosion channel, allowing water to bypass the sensor location and preventing normal pressure build-up (Toromanović *et al.*, 2025). In contrast, the bottommost upstream piezometer in the core soil showed slightly elevated residual pore pressures after the third and subsequent cycles, suggesting locally impeded drainage or reduced hydraulic conductivity. These different results show a complex response inside the dam, where softening and shifting of stress likely caused the changes.

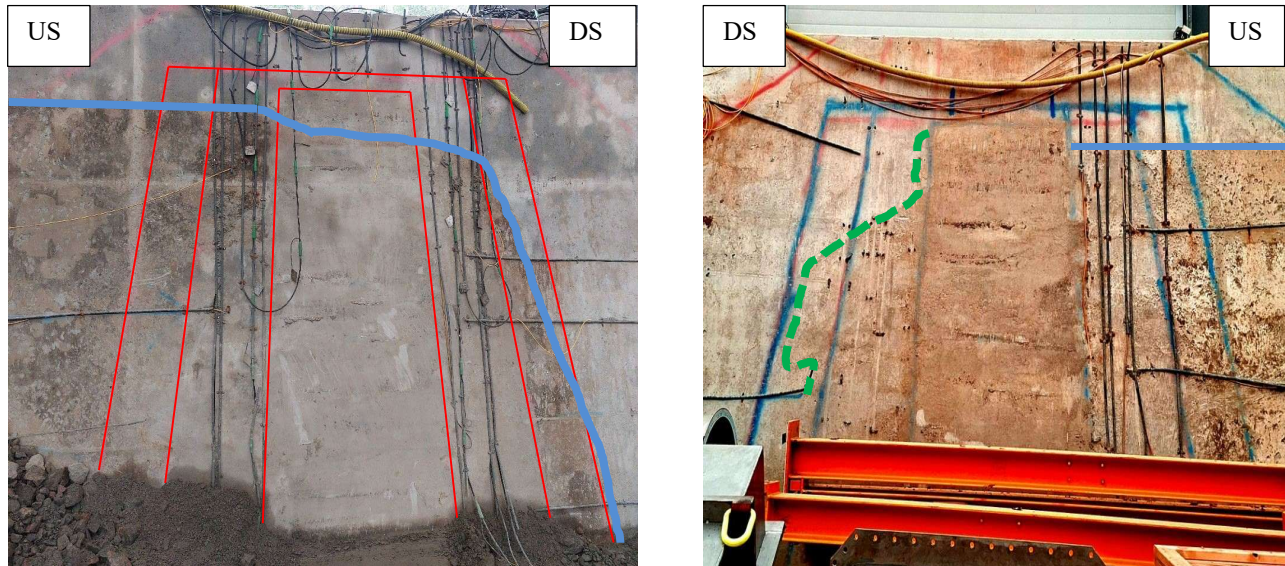
This hypothesis is supported, firstly, by field observations at both abutments, where a distinct imprint of the phreatic line was visible after 4.5 years of operation, see Figure 17. The imprint indicated that seepage was no longer being effectively drained through the fine filter but was instead emerging within the coarse filter. This observation suggests that

the fine filter's drainage function had been compromised and that erosion of the fine filter into the coarse filter had likely occurred. Such a sequential failure mode, initial filter degradation followed by core erosion, has been conceptually described in ICOLD (2017), but to the authors' knowledge, this study is one of the first real examples of this process in an embankment dam. Secondly, the large amounts of eroded core soil material discovered at the bottom of the downstream coarse filter support the hypothesis that the downstream fine filter, at an unknown number of locations, has been compromised.

Figure 17. To the left: Left abutment with the inner zoning of the dam marked with red lines and a phreatic line marked with a blue line. To the right: the right abutment. Inner zoning still visible from time of construction and phreatic line marked with blue line and the assumed phreatic line, downstream the core, marked with green dashed line (Lagerlund and Riaz, 2026).

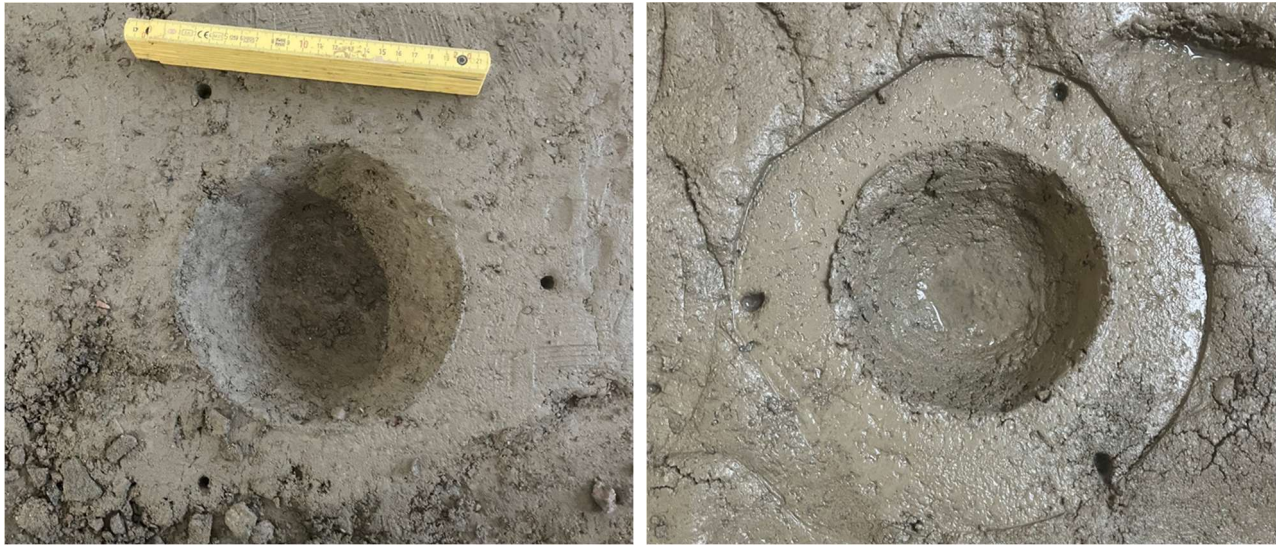
Dry density and water content measurements revealed significant spatial variability in compaction quality, even in the same layer. Several zones, particularly in the lower part of the core, exhibited lower-than-expected dry densities. In saturated areas, degrees of compaction exceeded 100%, likely due to underestimation of sample volume during field testing, see Figure 18. These unusual results show that normal field tests don't always work well in soft, wet soils.

Figure 18. Imprint of field density measurement equipment on core soil from the same layer. To the left, the picture show very stiff core soil and very wet and soft to the right (Lagerlund and Riaz, 2026).

- Develop better ways to make sure compaction is even, even when moisture levels change, for example, using flexible compaction methods and real-time moisture checks.
- Study how uneven filter material placement can lead to erosion, using lab and field tests.
- Test the two-step erosion process in controlled experiments to confirm how it works.
- Study how erosion features change over time when water levels go up and down, to help improve dam safety checks.
- Look at how to combine construction records, dismantling data, and monitoring results to better spot early signs of erosion and understand what caused it.
