Performance of flood defences in the Netherlands during the 2021 Summer floods

André Koelewijn¹, Joost Pol² and Malou van Schaijk³

Flood defences, Levees, Failures, Emergency response, Field cases.

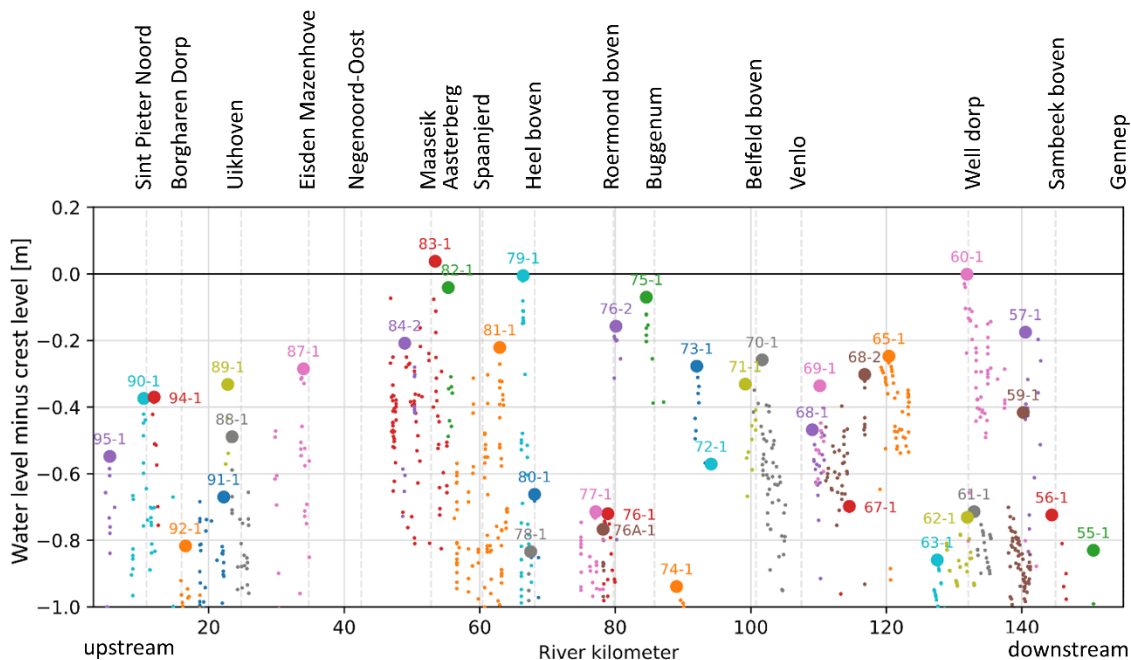
crest level and the water level are compared for the dike sections along the Meuse between the Belgian-Dutch border (kilometre 0) and the village of Gennepe (kilometre 155). Each point represents a dike section and the most critical point of each dike ring area is shown with a bigger marker and its code number. It should also be noted that there may be small differences between this figure and the situation in the field during the flood, because of both changes that occurred since the survey for AHN3 (the third version of the nationwide digital elevation model of the Netherlands), and local differences between the hydrological model and reality, resulting from e.g. the model grid size and local backwater effects.

Figure 2: Differences between crest level derived from elevation model AHN3 and modelled water levels for all dike sections along the Meuse between the Belgian-Dutch border and Gennepe (figure courtesy of Jurjen de Jong, Deltares).

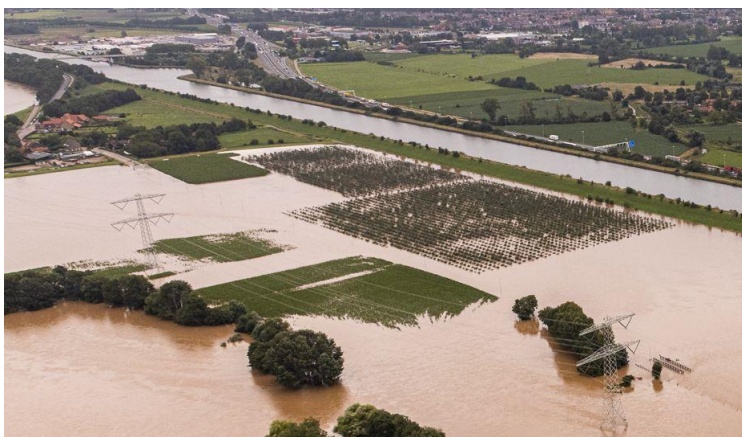
An example of this is the dike section 82, locally known as Aasterberg (Figure 3). During the peak of the floods along the Meuse, locally on Friday 16 July, the water level near to the northern side of this small dike section rose higher than the crest of the dike (contrary to what the previous figure suggests). Sandbags had been installed in time on the raised road behind the dike which prevented the area from flooding. The residents were evacuated (Limburg, 2021a). At the critical sections indicated in Figure 2, most notably dike section 83, sand bags were applied as an effective measure.

Figure 3: Aerial view of Aasterberg (upper left corner) on July 16, 2021, a few hours before peak flood level (photograph Dutch Coast Guard).

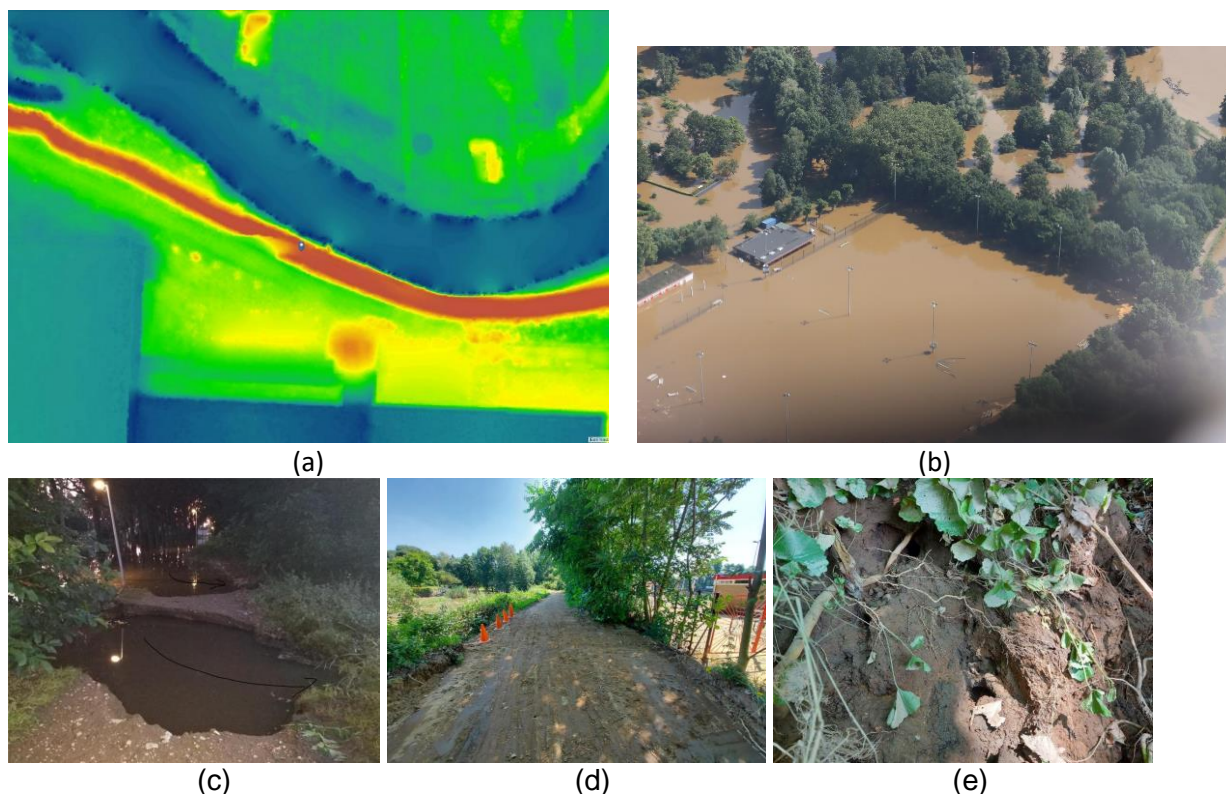
A breach approximately 2 m wide occurred in the dike after an overflow of a slightly lower part of the crest (Figure 4). At this location, the crest height is NAP + 21.10 to + 21.20 m while the maximum water level was NAP + 21.43 m, as indicated by measurements at station “Roermond Andersonweg bij stuw Hoge Bat” [<https://www.waterstandlimburg.nl/Home/Waterstanden/140>]. High-water marks on the nearby floodgate to the west of the Bisschop Lindanussingel indicate a similar level, which must have been the same at the breach location, because there was hardly any current in this branch of the Roer as the downstream floodgate was closed (see Section 2.6). Due to the flooding, the hockey fields were almost 2 metres underwater. Based on several sources of information, the following timeline of events can be reconstructed:

Figure 4: Concordia hockey fields: (a) digital terrain model showing locally lowered crest at the first breach location, situation before the floods (from the nationwide elevation model AHN3), (b) aerial photograph taken on Saturday 17 July at 11:15 AM – the dike with breach is located just behind the clubhouse and the blue container among the trees (photograph Dutch Coast Guard), (c) situation with backflows with the scoured location of the lower crest at the front and the breach location behind (photograph David Knops, HKV), (d) sealed breach, : holes in dike embankment approximately 100 m from the location of the breach.

It is not known when exactly the breach occurred, whether this was before the water entered the area or after. Therefore, the failure mechanism at this location cannot be inferred clearly from the observations. As the maximum water level in the Roer exceeded the local depression in crest level, external erosion by overflowing water is a likely candidate. Traces of external erosion at the inner slope have been observed on the same levee, about 100-200 m from the breach

location. It is also possible that burrowing by animals played a role in the weakening of the levee and the occurrence of the breach: holes several centimetres in diameter were found in a number of places in the dike embankment near the breach location, possibly made by voles (Figure 4e). These holes increase the vulnerability for saturation and slope instability and internal erosion from the embankment body. However, if the breach occurred after the area flooded due to overflow, a possible failure mechanism is that the breach was caused by the outflowing water, for instance external erosion or slope instability of the outward slope (by then, the river level was lower and the levee must have been saturated).

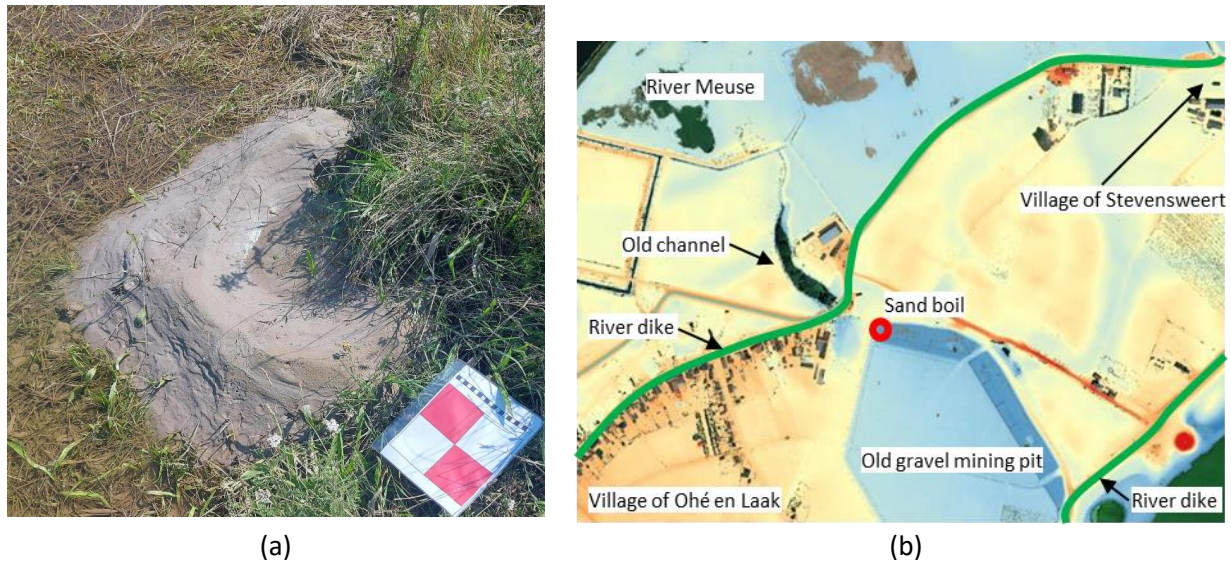
A sand boil at St. Annakapel near the village of Ohé en Laak, was not discovered until the water had subsided (Figure 6a). This sand crater measuring 120 cm in diameter was located approximately 100 m from the landside dike toe, in an area that had become low-lying on account of gravel extraction carried out in the past, see Figure 6b. The maximum water level difference across the dike here was approximately 4 m. The combination of a low-lying, highly permeable subsoil, and the presence of an old channel belt under the dike makes this location particularly vulnerable to the development of seepage and possibly backward erosion piping. Further investigation of the local subsoil is required to reveal where the sand came from and whether additional reinforcement measures to protect against piping are required.

Figure 6: (a) Remnants of a sand boil near St. Annakapel observed after the floods. The sand deposited is relatively fine. (b) ground level in the area of the sand boil (based on the nationwide elevation model AHN3), the dikes are indicated by means of a green line.

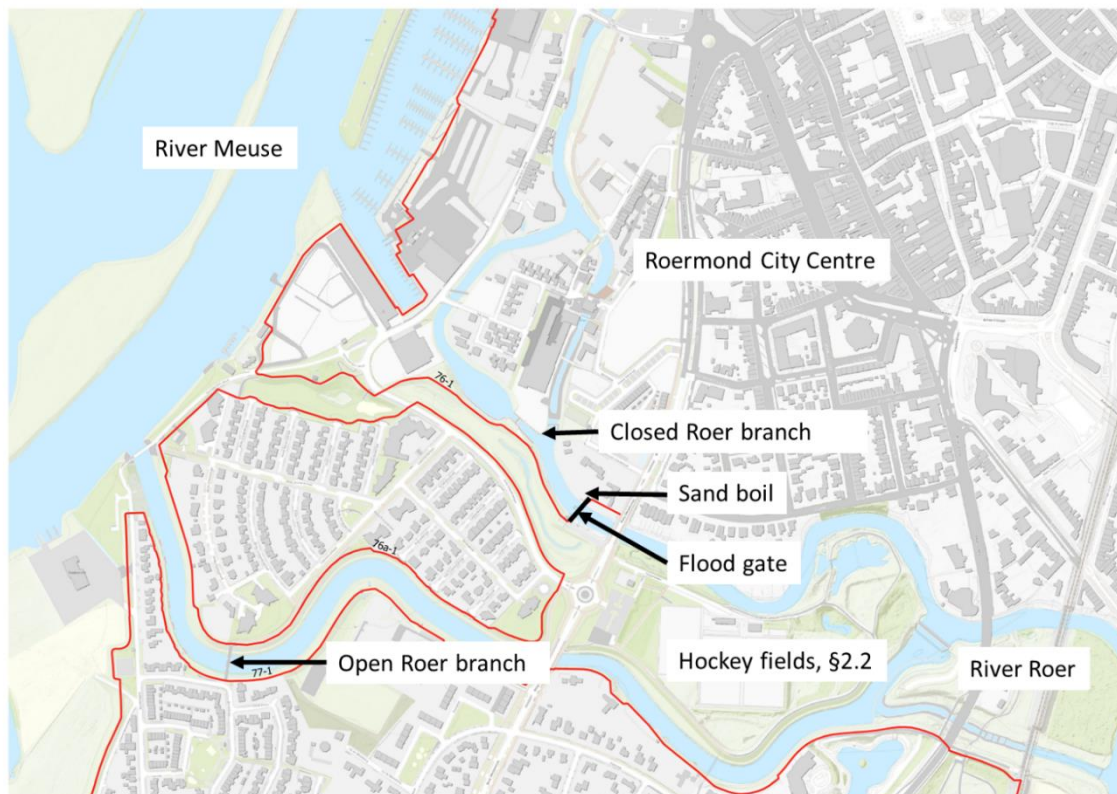
Figure 8: Overview of the area around the Roer flood gate in Roermond.

Another incident with internal erosion occurred at a floodgate in the city of Roermond (Figure 8). This floodgate in the Roer river, which is a tributary of the Meuse river, was closed in order to protect the city centre from flooding. At this location, excessive seepage and erosion in the corner of the L-shaped wall on the downstream side was reported on Saturday 17 July at 03:15 AM. The sand boil was bringing up coarse sand and gravel. Half an hour later, the first ring of sandbags was put down (see Figure 9ab) which was eventually built 3 to 4 layers high (Figure 9c). This stopped the erosion process. In the afternoon, again outflow of water and sand was reported, and the ring of sandbags was heightened to a height of 60 to 80 cm which turned out to be sufficient to stop the erosion for the maximum water level drop of more than 1.6 m that was present over the structure. To be sure to stop further erosion, the area near the corner was completely filled with sandbags [Figure 9c].

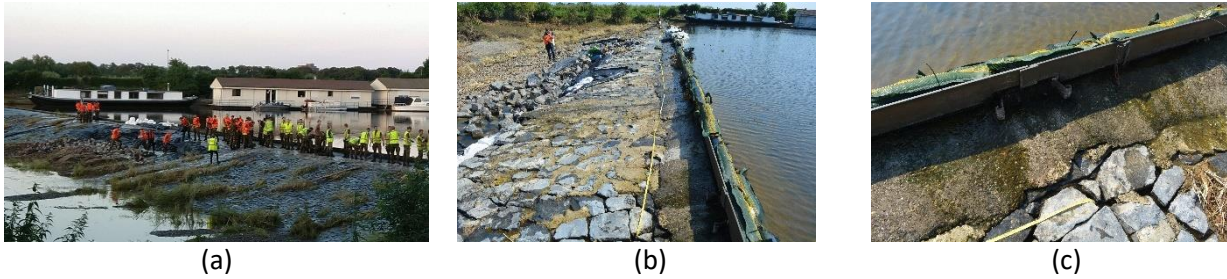
The Borgharen barrage is located directly downstream of the Julian Canal's entrance in the Meuse floodplain, between Maastricht and Borgharen. The Bosscherveld bypass which incorporates a fixed barrage runs parallel to this. That barrage consists of an earth dam with stone revetment on the downstream side. On top of the dam, there is a steel edge approximately 15 cm high, consisting of anchored elements which are each 4 m long. When the water level dropped, it was found that one of these steel elements that was located roughly in the middle of the dam had disappeared. Behind was an erosion hole approximately 15 m wide and up to around 1.5 m deep. This became visible during the afternoon of Saturday 17 July, when the discharge via the barrage was already significantly reduced. It was decided to carry out an acute emergency repair for which the army was also deployed (Limburg, 2021c) on account of the poor accessibility of the location with equipment, see Figure 10.

Incidentally, the abovementioned damage was at the same location as previous damage which occurred about ten years ago. The repairs probably created a weak spot. In addition, the detailing of the anchoring of the steel edge, with an easily removable locking pin, seems susceptible to vandalism.

Figure 10: Barrage near Bosscherveld: (a) emergency repairs with the assistance of the army (photograph Wilbur van Beijnen, Directorate-General for Public Works and Water Management), (b) overview of defence after repair (high-water marks still visible from the vegetation in the background), (c) detail of anchoring of steel edge.

Despite not being a critical situation, partly because a dam-break flow would remain within the Meuse river, it was decided to carry out the immediate repairs on account of further damage in case of a possible second flood event. For instance, a further widening of the erosion hole could cause the crest to collapse and further erode the earth dam in a lateral direction. The accessibility for repairs would get much more problematic in that case. At the same time, the water level at Borgharen would no longer be controllable by the barrage, which is important for the stability of structures in the Juliana Canal.

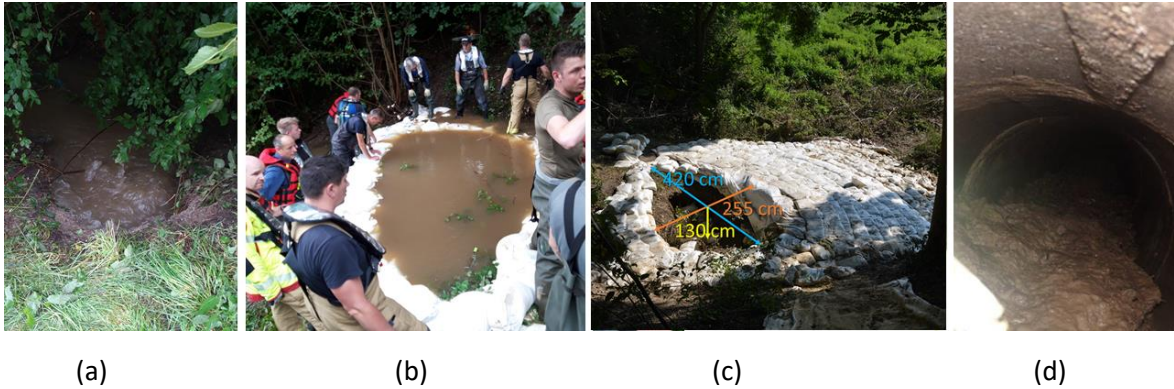
On the afternoon of Friday 16 July, various media reported that a dike had breached near the village of Meerssen or Bunde (1Limburg, 2021b) - (RTL News, 2021) - (De Telegraaf, 2021). On closer inspection, it was found to be a substantial sediment-carrying flow of water which also washed out gravel, just to the north of the approach road leading to the bridge over the Juliana Canal near Bunde, see Figure 14 and Figure 15. As a matter of urgency, this water flow – that was mistaken for a large sand boil– was handled by installing a coffer dam more than a metre high consisting of around 3000 sandbags which stabilised the situation. It was initially thought that the dike along the Juliana Canal which is elevated here was on the verge of failing due to a leak from the canal or from the Meuse. However, it was water from the Geul that was the problem, see Figure 15. Because not all of it could flow through the culvert under the Juliana Canal, it flowed along the eastern side of the Juliana Canal to the north. At the approach roads leading to the bridges near Bunde and Geulle, water then flowed around the road and through the originally constructed culverts. However, near Bunde the culvert had become covered and was not included in asset databases so that the flow of water from this culvert was initially misinterpreted as coming from the subsoil (“sand boiling”). It was discovered that there was a culvert here a week later when further investigation of this location was carried out. This last example clearly shows how the capacity of emergency services can be absorbed to a significant extent by issues that appear to be irrelevant at hindsight – or with sufficiently

Figure 14: Situation near Bunde: (a) prior to effective measures (photograph Bertram de Rooij, WUR/Fire Service Gelderland Midden), (b) stabilised boiling (photograph Hoite Detmar, the Directorate-General for Public Works and Water Management), (c) boiling area with dimensions after drying out, (d) the concrete culvert where the water came out (photograph Anton van der Meer, Deltares).
