The Weakest Link

Degradation of a weld through interaction with hydrogen

Jonas Cop
Charlot Depestel
Nathalie Saikali
Sharon Temmerman
Dorien Zeebroek

Department of Materials, Textiles and
Chemical Engineering (MaTCh)
Faculty of Engineering and Architecture
Ghent University, BELGIUM
Kim.Verbeke@UGent.be

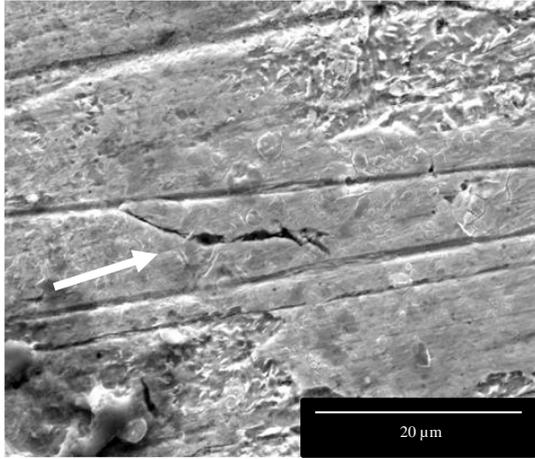
SEM images of the weld after the in-situ constant-load tensile test are shown in Figures 6 and 7. Small cracks were found inside the filler material, as presented in Figure 6. An overview SEM image of the weld after the in-situ constant-load tensile test is shown in Figure 7. The different sections of the heat affected zone and the direction of the tensile force are indicated on the figure as well.

Figure 6: Hydrogen induced crack in filler material during in-situ constant-load tensile test under hydrogen charging.

The heat affected zones contained the least amount of hydrogen, whereas the hydrogen concentration of the filler was the highest compared to the other zones. Therefore, the heat affected zones would be the most resistant to hydrogen-induced damage based on this criterion only. In contrast, the filler was most susceptible to hydrogen uptake, which explains the hydrogen induced cracks formed in the filler during the in-situ constant-load tensile test, as represented in Figure 6.

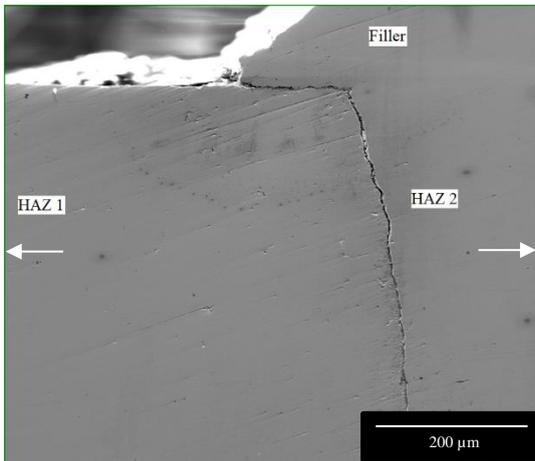
Figure 7: SEM image of the weld after in-situ constant-load tensile testing: crack initiating at the base of the filler and propagating into HAZ 2.

As can be seen in Figure 7, cracking of the weld started at the filler, despite this zone being the least brittle part of the HAZ. This can be explained by the higher amount of hydrogen in this zone, as indicated by the TDS results in Figure 8 and Table 2. This, combined with the stress concentration existing at the base of the filler, resulted in crack initiation parallel to the tensile direction along the boundary between the filler and the HAZ, as observed in Figure 7.

Further crack propagation, however, occurred perpendicular to the tensile direction as the crack deflected into the heat affected zone. More particularly, crack propagation occurred in HAZ 2, which was found to have the highest hardness of the heat affected zone, cf. Figure 9. Therefore HAZ 2 provided one of the conditions for hydrogen-induced cracking, i.e. a susceptible microstructure. Consequently, once a crack is formed, the heat affected zone acts susceptible to crack propagation.

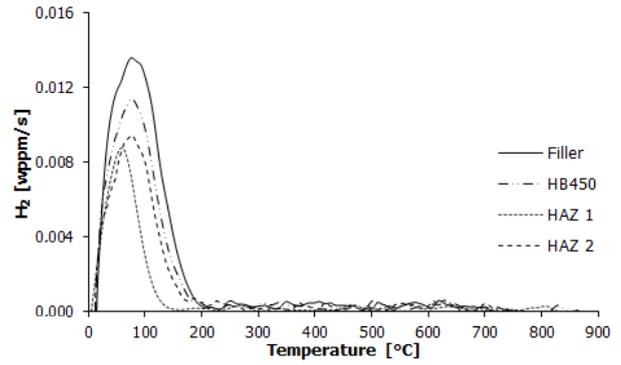
Thermal desorption spectroscopy was used to measure the hydrogen uptake and trapping capacity in the different zones. A higher hydrogen concentration implies increased solubility of hydrogen in the microstructure. The resulting TDS spectra can be found in Figure 8, with the concentration of hydrogen in the different zones given in Table 2. For all different zones of the weld, the TDS spectra show only one peak at a relatively low temperature, indicating that hydrogen was trapped at weak trapping sites, e.g. dislocations and grain boundaries, in all zones [5].

Figure 8: TDS spectra of the different zones of the weld.

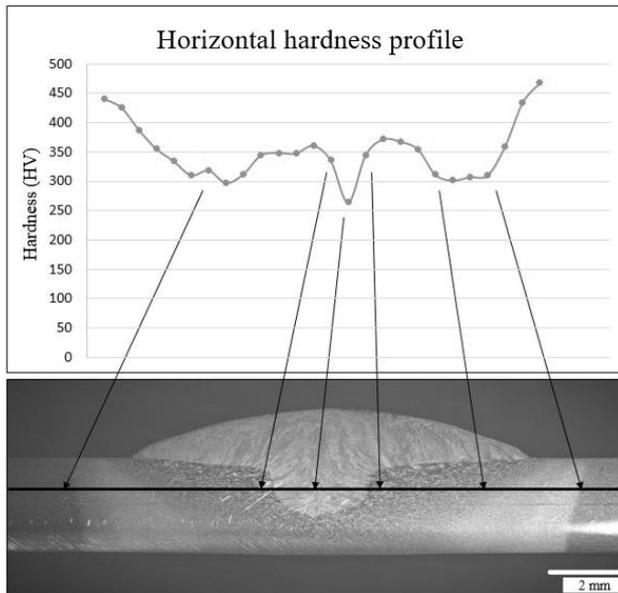
However, besides the hydrogen uptake and trapping capacity of a zone, also the hardness influences the material's behaviour towards hydrogen-induced damage. Therefore, a horizontal hardness profile was obtained, as can be seen in Figure 9. Starting from the base material, the hardness initially decreased when approaching the zone corresponding to HAZ 1. This is in accordance with the observation of a martensitic microstructure for HB450, as shown in Figure 2, and a tempered (and therefore less strong) martensitic microstructure of HAZ 1, visualized in Figure 4.

Closer to the weld, however, the hardness increased again in HAZ 2. In this zone, austenite (formed during welding) was transformed back into martensite upon cooling, as such resulting in a martensitic microstructure, as given in Figure 5. The hardness in the heat affected zone was still remarkably lower than in the base material since the cooling rate after welding was not controlled, as opposed to the cooling rate during initial production of the base material. During industrial production, the steel can be cooled significantly faster, resulting in a higher hardness of the martensite in the base material compared to HAZ 2. The higher hardness of HB450 with respect to HAZ 2 is in accordance with the observation of a fine needle-like martensitic microstructure for the base material compared to a coarse needle-like martensitic microstructure of HAZ 2, since in general a finer martensite lath thickness increases the material's hardness.

The filler material was identified to be the softest phase of all different zones of the weld. This is in accordance with the observation of an acicular ferritic microstructure, as shown in Figure 3, compared to the (tempered) martensitic microstructures of the base material and heat affected zones.

Figure 9: Horizontal hardness profile along the weld.
