Experimental Investigation on the Structural Performance of Square Hollow Glass Columns Under Axial Compression

Suinan Zhao^a, Suwen Chen^a

Challenging Glass 7
Conference on Architectural and Structural Applications of Glass
Belis, Bos & Louter (Eds.), Ghent University, September 2020.
ISBN 978-94-6366-296-3, www.challengingglass.com

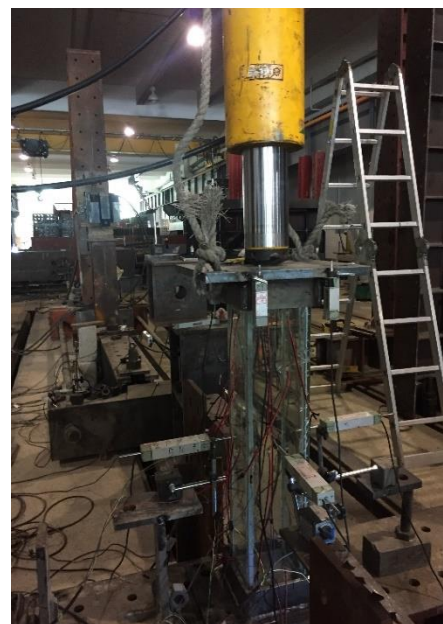
Fig. 3 Test setup.

In order to avoid direct contact between glass columns and the steel support which may lead to premature failure of glass, a plastic pad (PMMA) was used as shown in Figure3. These pads were designed as a two-stage component. Loads were transferred from the steel shoes to glass columns via PMMA pads, and this design can also limit twisting at the top and bottom of the specimen. After the glass columns and PMMA pads were relatively fixed, they were placed into a steel support.

The test setup is shown in Figure 3. Hydraulic jack was used for loading. The whole test was carried out in a load-controlled manner with hierarchical loading method. The load gap between each stage was 10kN and the loading speed is around 10kN/min up to collapse.

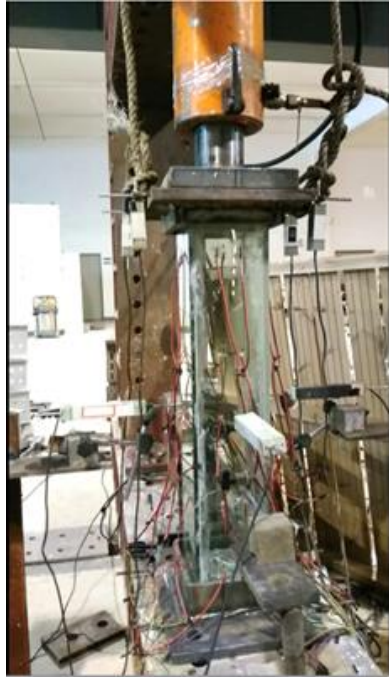
Fig. 5 Location of the first crack of M1.

As shown in Figure 5, the first crack, located at the top of the column (panel B), occurred at the attainment of a compressive load almost equal to $N_{cr,1}=659.1\text{kN}$. The further increase of the compressive load N led to a propagation of cracks up to the collapse of the specimen. The failure load was $N_{max,1}=688.5\text{kN}$ which showed a little residual strength.

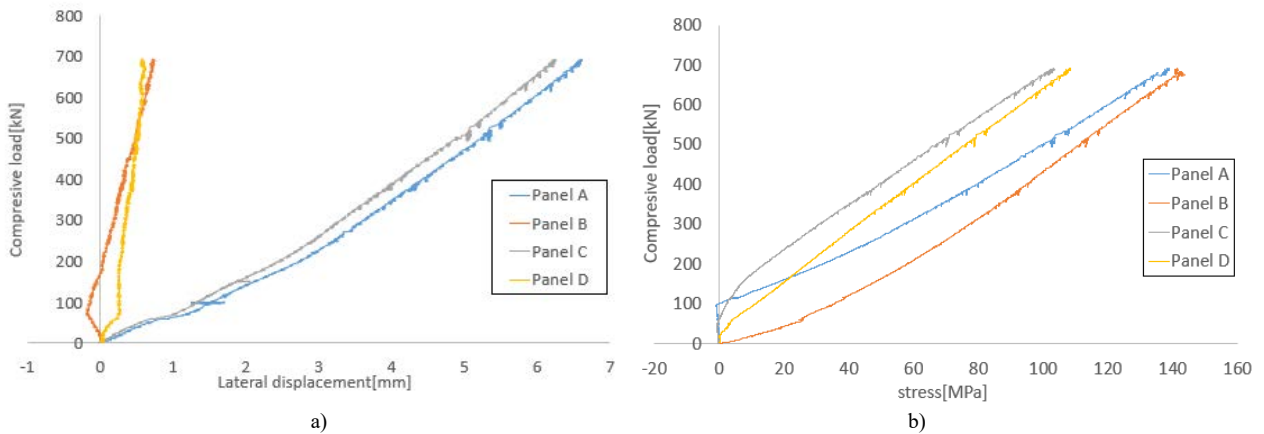
Fig. 6 a) Lateral displacement of mid-span cross-section b) compressive stress of mid-span cross-section of M1.

Figure 6 a) shows the increase of mid-span lateral displacement of four panels, as a function of the load N . Apparently panels A and C had approximative lateral deflections in the same direction, while negligible displacements were obtained for panels B and D, which showed a trend of global bending of the specimen.

Figure 6 b) proposes the increase of compressive stresses σ of the glass panels, as a function of the applied compressive load N . As shown, the straightness is not stable at the beginning of the test. The reason of this phenomenon was that four glass panels were different in height. When the compressive load was not high enough, there was still some space between the specimen and support. Hence the stress distribution in the cross-section was uneven which was also the reason why the compressive stress of every panel differed from each other's during the whole test.
