## Vulnerability of transport infrastructure to extreme weather events in small rural catchments

Across the Mediterranean region, extreme weather events (EWE), such as high-intensity storms causing flooding in small river basins, are one of the most common types of hydro-meteorological hazards. Flooding has been associated with severe effects on road networks and a significant number of vehicle-related fatalities, raising concerns regarding the performance of transportation infrastructure during EWEs. Given the expected increase in frequency of such events within the context of climate change, an assessment of its vulnerability is particularly crucial. The work presented herein evaluates the performance of transportation infrastructure during high-intensity storms. This research focuses on small rural catchments, examining the impact of five extreme storm events in five rural basins in Greece. Post-flood surveys were conducted, to record the impact of inundation on each infrastructure element in the five catchments. Overall, findings showed that road infrastructure, especially river crossings, performed poorly, restricting access to large areas during and after the events, affecti

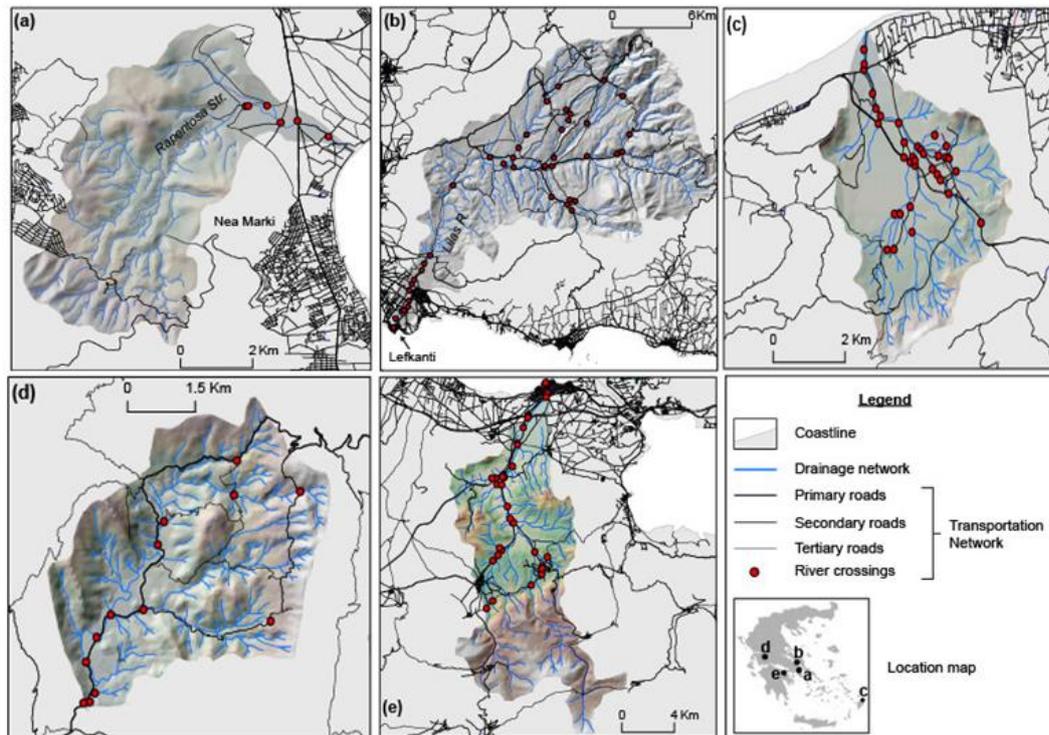
Figure 1. Maps of (a) Rapentosa, (b) Lilas, (c) Kremasti, (d) Potamoula and (e) Xerias river basins, illustrating the local drainage and the paved transportation network along with the established river crossings

approximately 25 km northeast of the capital, Athens. In this case Vranas torrent drains a mountainous area of 25 km<sup>2</sup>, through the Marathon plain and into south Euboikos Gulf (Figure 1a). The second is situated on the island of Euboea, in central Greece. Lilas River drains a coastal but mountainous rural area (259.4 km<sup>2</sup>) of central Euboea (Figure 1b). The third, Kremasti River basin, is situated on the northern part of the island of Rhodes in southeast Greece. The river drains a coastal rural area of 22.9 km<sup>2</sup>, around the villages of Pastida and Kremasti (Figure 1c). The fourth lies in western Greece, 15 km northeast of Agrinio. Platanorema River drains an area of 26.1 km<sup>2</sup> around the village of Potamoula (Figure 1d). The fifth, Xerias River basin, is situated in north Peloponnese, draining a mountainous area of 155.9 km<sup>2</sup> in the Gulf of Corinth. Corinth, the biggest town in the catchment, is built around the river's outlet (Figure 1e).

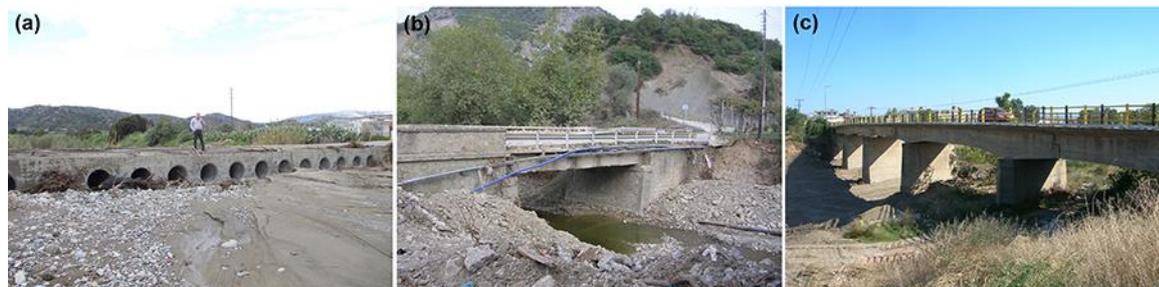
Figure 2. Types of river crossings: (a) low water crossings, (b) single-span bridges and (c) multi-span bridges

- Low water crossings: Pathways constructed out of asphalt or concrete with shallow foundation, used as a bridge when water flow is low (Figure 2a).
- Single-span bridges (no piers): Concrete structures, single-span bridges have abutments at each end that support the weight of the bridge and serve as retaining walls (Figure 2b).
- Multi-span bridges (with piers): Concrete structures, which use piers to support the weight of the structure at the end of each span and between the abutments (Figure 2c).

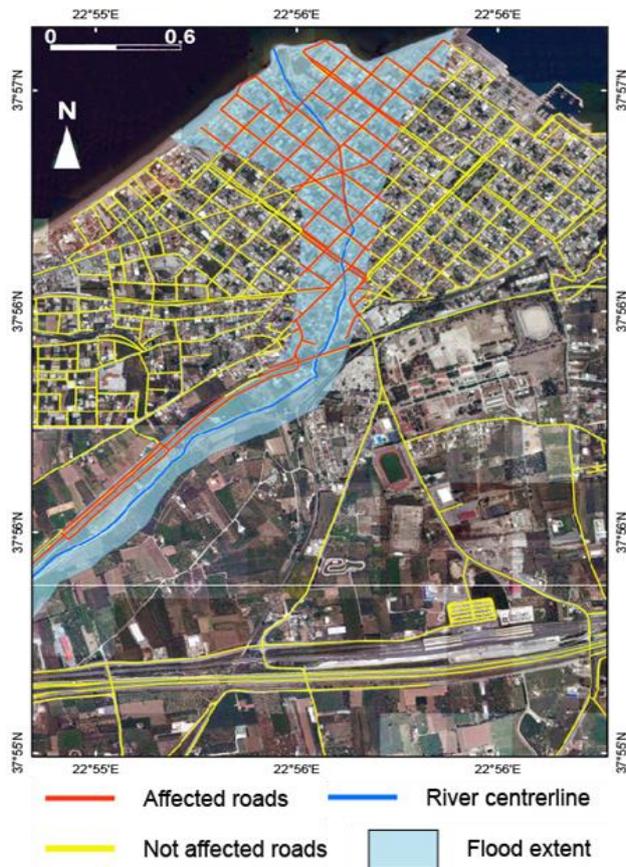
Figure 3. Maps of Xerias river basin near its outlet at the town of Corinth, illustrating the extent of flooding as mapped during the post-flood fieldwork, and the affected part of the road network

Using the delineation of the flooded area, the affected part of the road network was accurately mapped (Figure 3). The damages on the roads and the river crossings were categorized in different groups according to their type. Simple mathematical operations were carried out to quantify the extent of the effects on the road network and particularly on the river crossings.

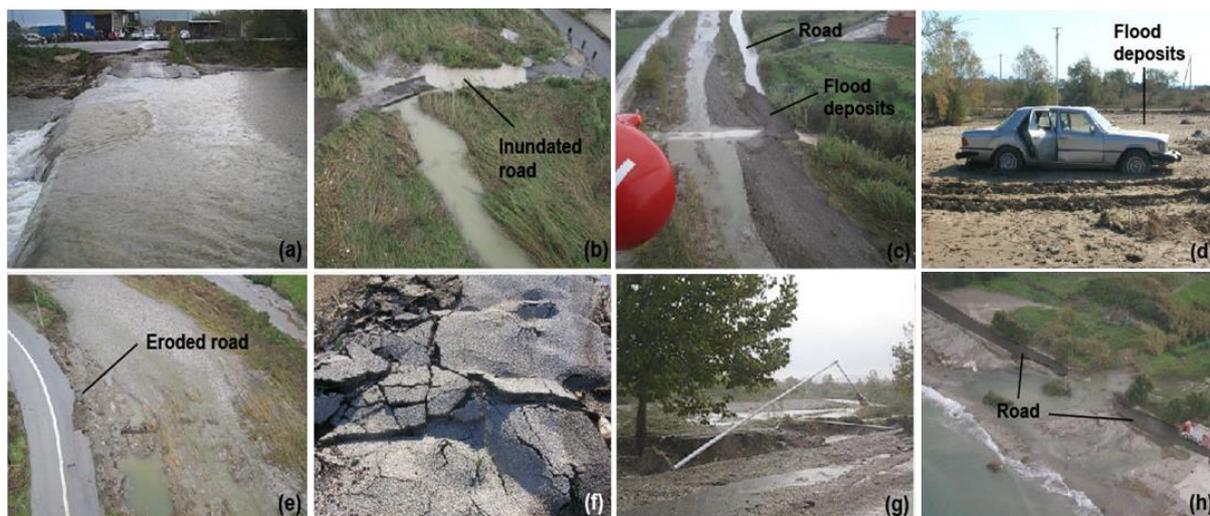
- a. Inundation of parts of the road network causing no permanent damage or effect of a structural nature, but restricting vehicle circulation during the flood and up to several hours after it, by making these parts of the network impassable (Figures 4a, b).

- b. Inundation of parts of the road network accompanied by debris and sediment accumulation or deposition on parts of the road network, restricting access (Figure 4c) and vehicle circulation during and after the flood (sometimes for 1 or 2 days) and immobilizing vehicles (Figure 4d).

- c. Inundation of parts of the road network accompanied by erosion and scouring of the road fill material, its embankments or its foundations and subsidence of the road surface (Figure 4e).

- d. Inundation of parts of the road network accompanied by surficial scouring limited to the asphalt, the road pavement or the shoulders (Figure 4f).
- e. Inundation of parts of the road network accompanied by damages on various road installations such as street lighting, road signs, traffic lights, guardrails and others (Figure 4g).

- f. Inundation of parts of the road network accompanied by complete collapse of whole parts of the road network due to erosion and scouring, together with the foundation material and the asphalt deck (Figure 4h).

Figure 4. Effects of flash flooding caused by extreme precipitation events on the road network including: inundated parts (a, b), deposits of debris (c, d), eroded road fill and scoured roads (e), asphalt scouring (f), damages on road equipment (e.g. lighting installations) and (g) complete erosion and road collapse (h)

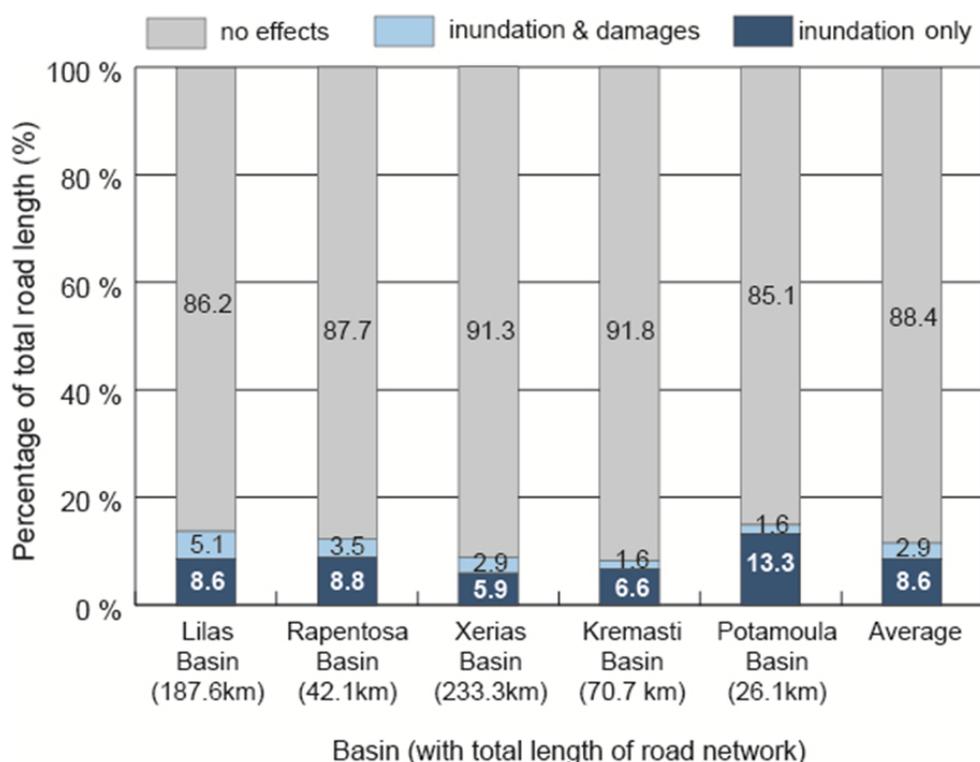
- the length of roads that suffered both inundation and damages ranged between 0.4 and 9.7 km (1.6% - 5.1% of the total road length) depending on the basin
- the length of roads that experienced only inundation ranged between 3.5 and 16.2km (5.9% - 13.3% of the total road length) depending on the basin
- the length of roads that experienced either inundation or inundation and damages ranged between 3.9 and 25.9 km (8.2%-13.8% of the total road length) depending on the basin
- On average 2.9% of the total length of the road network of a basin experienced both inundation and damages and 11.5% experienced either inundation or inundation and damages. An average of 88.4% did not experience any effects (Figure 5).

Figure 5. Percentage of total road length of the examined basins that experienced temporary inundation and damages during the EWEs

Significant parts of the paved road network of the five study areas experienced the above effects during extreme precipitation events and the subsequent flooding (Figure 5). Results showed that:

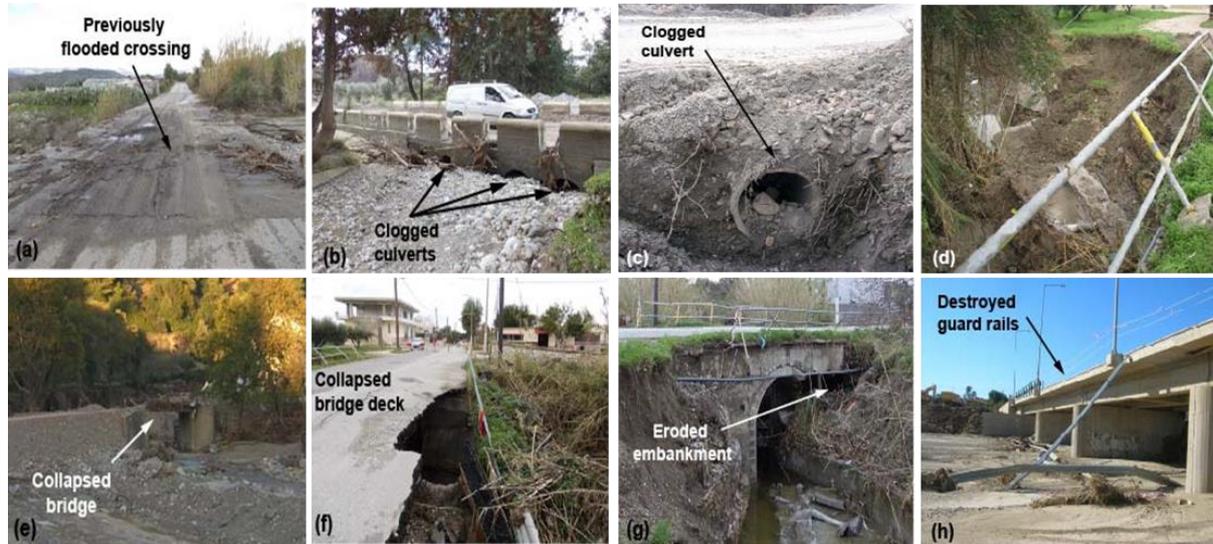
- Type 2: River crossing experienced inundation, cutting access to vehicles, but with no structural damages on any element of the infrastructure (Figure 6a).

- Type 3: River crossing experienced inundation after clogging of its culverts or other waterways. Access across the watercourse was restricted after the flood (for hours and up to 1-2 days), as water continued to overflow due to the blocked pathways. No further structural damages on any element of the infrastructure was present in this case (Figures 6b, c).

- Type 4: River crossing experienced inundation accompanied by damages on parts of the infrastructure such as: destroyed guardrails, debris accumulation on the bridge deck, partial scouring on the bridge foundations, damage on street lighting / road signs / traffic lights, scouring on the asphalt deck, scouring and erosion of embankments or fill material. In this category, all effects and damages were fully restorable without the complete demolition of the river crossing in question. However, the functionality of the infrastructure was restored after a considerable amount of time, ranging from 3 days up to a few weeks (Figures 6d, f, h).

- e. Type 5: River crossing experienced inundation accompanied by critical damages that caused the complete collapse of its structure or damages that cancelled the functionality of infrastructure permanently. In most cases, the collapse or critical damage came with scouring or erosion of foundations of the bridge (abutments or piers) followed by substantial subsidence of the bridge deck and its support. In this category, the effects and damages were not restorable. The functionality of the infrastructure was restored after weeks or months (Figures 6e, g).

Figure 6. Types of damages on river crossing infrastructure, ranging from inundation only (a), clogging of waterways (b, c), damages on parts of a bridge (d, f, h) and complete collapse of the infrastructure (e, g)

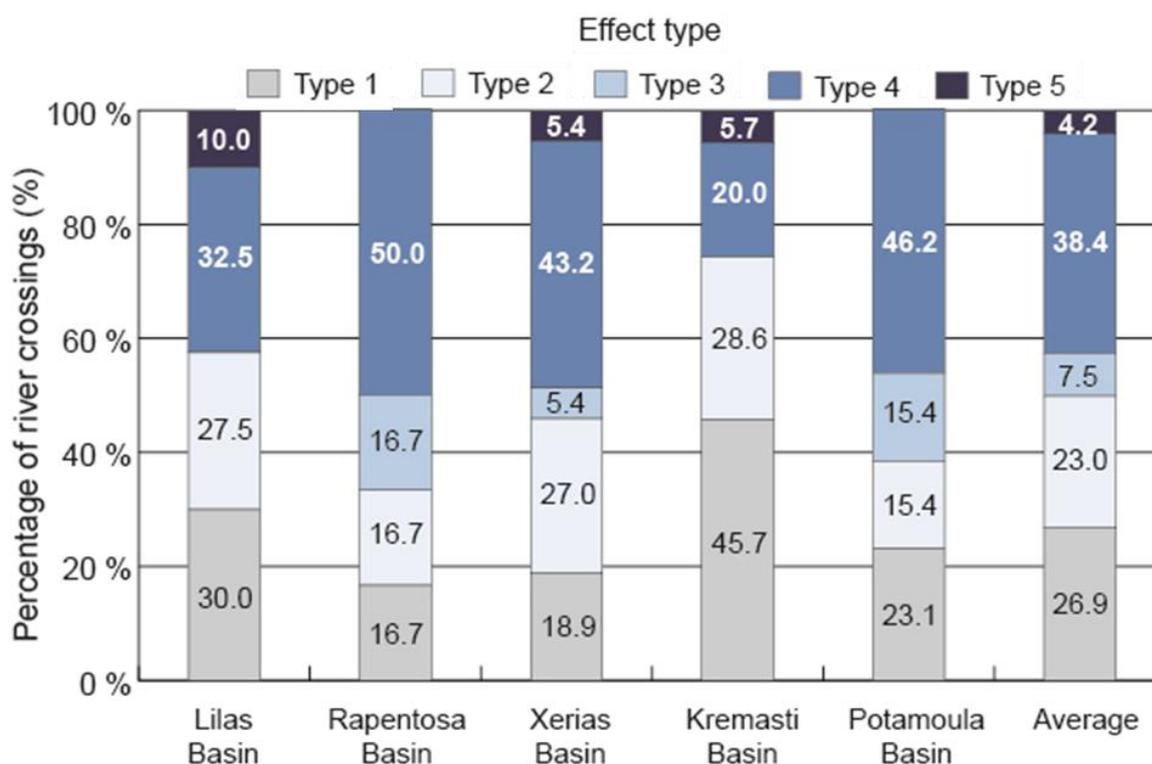
Figure 7. Percentages of effect type per examined basin

Based on these results, an average 73.1% of river crossings in each basin was found to experience inundation, making these passages impossible to cross. On the contrary, an average of only 26.9% experienced no effects from the precipitation events and the subsequent flooding. In a significant part of these river crossings (50.1% on average), in addition to inundation, the floodwaters also caused damages to the road deck, culverts, guardrails, street lights and other installations. However, the particular damage to infrastructure did not lead to collapse, and was restorable (Figure 7).

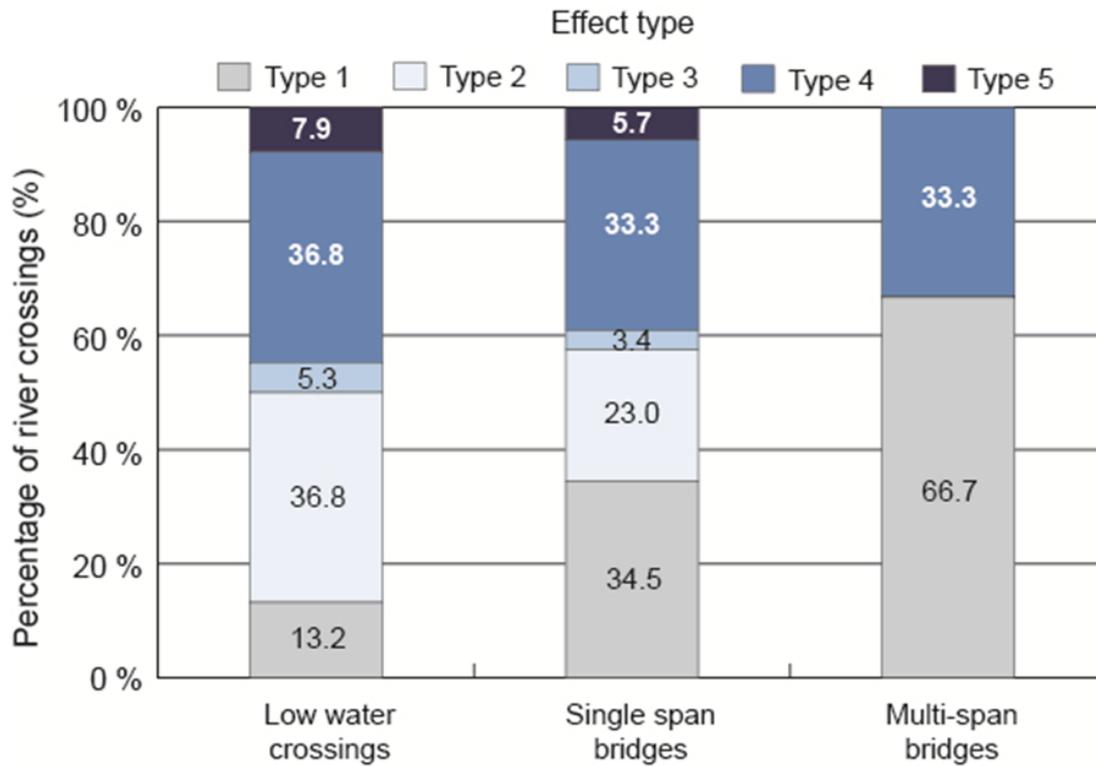
The type of damage appeared to be related with the type of infrastructure (Figure 8). Out of 38 cases of "low water crossings", 86.8% were inundated, 42.1% experienced damages and 7.9% suffered non-restorable damages or collapsed. Out of 87 cases of single-span bridges, 65.5% were inundated, 36.8% were damaged and 5.7% suffered non-restorable damages or collapsed. In 6 cases of multi-span bridges, 33% were flooded and damaged, but none of them collapsed or suffered critical damage. Low water crossings were found to be more vulnerable to inundation and to damages from extreme precipitation events and subsequent flash flooding, as only 13.2% of them were not affected (Figure 8). On the contrary, multi-span bridges presented less vulnerability than the other two types, with 66.7% not suffering any effect from flooding. This difference can probably be attributed to the larger cross sectional areas.

Figure 8. Percentages of effect type on river crossings

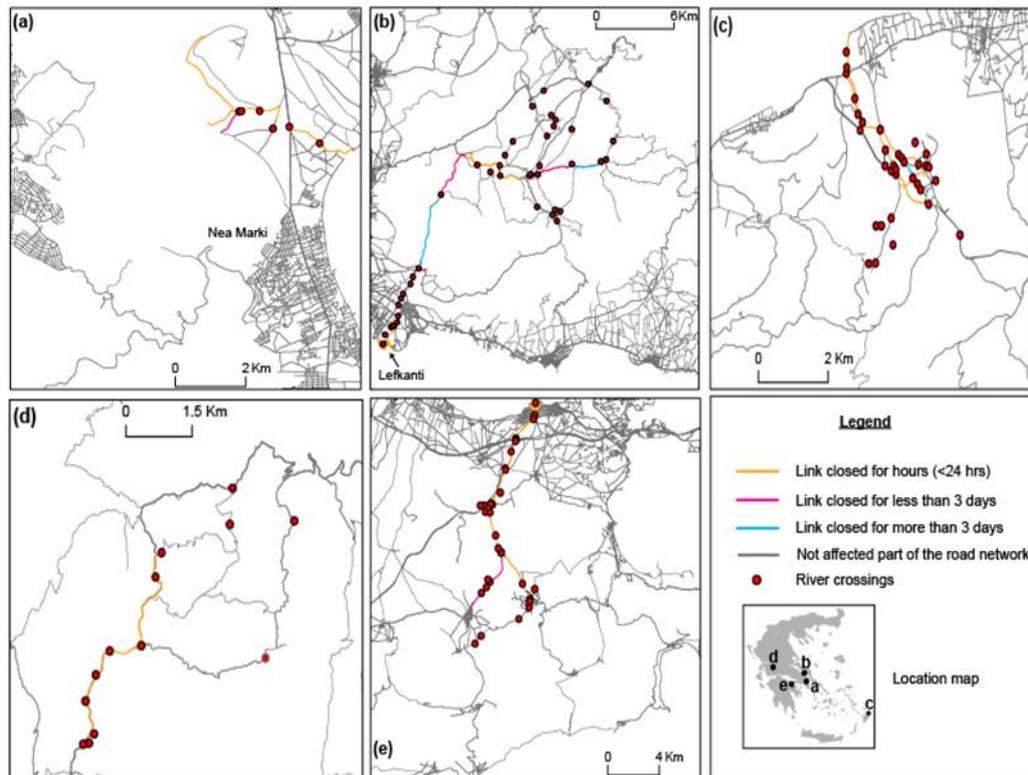
Figure 9. Closed road network after the extreme precipitation events per examined basin

Post-event field visits showed that parts of the road network in all five basins had to close for hours and up to weeks so that restoration works could be carried out. Although specific data for vehicle circulation were not available for the study areas, closed parts of the road lead to changes (detours) of vehicle itineraries.
