UNDERSTANDING THE VULNERABILITY OF HISTORIC URBAN SITES

Nuran Zeren Gulersoy¹ | A. Balin Koyunoglu²

1 Istanbul Technical University

2 FMV Isik University

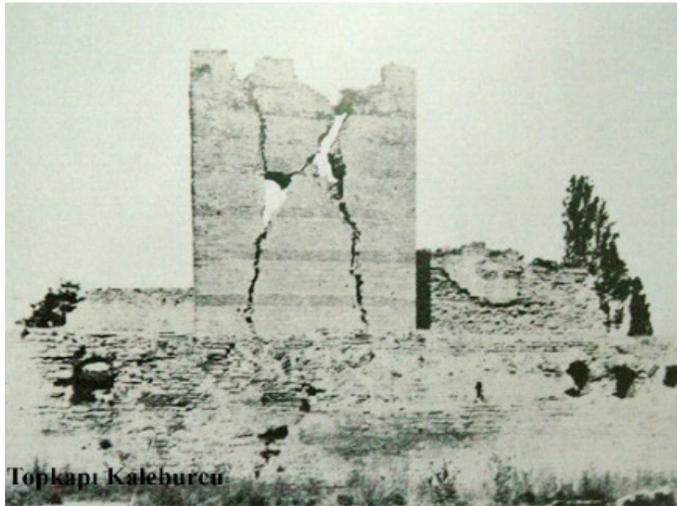
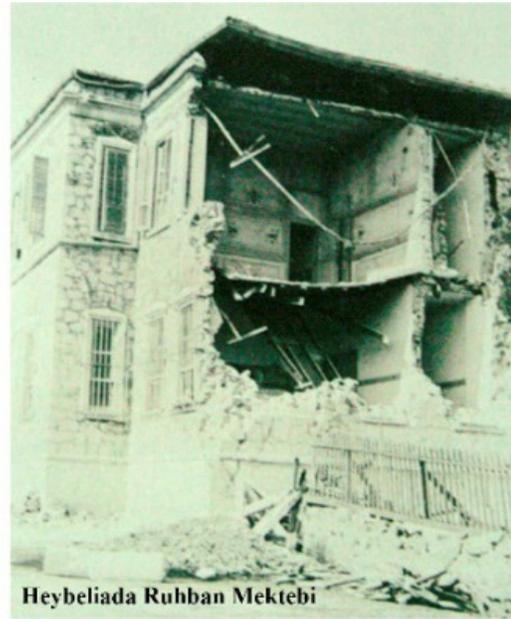
The second major disaster was the 1509 earthquake, which was as known as the “Little Doomsday” (Figure 1). This disaster was one of the strongest earthquakes of the last five centuries in the Eastern Mediterranean region. It occurred in the Marmara Sea on September 10, 1509.⁴ The earthquake destroyed the urban center of Istanbul. In the early 16th century, Istanbul had an approximate population of 160 thousand, and the Galata neighborhood had 35 thousand households. The earthquake destroyed over a thousand residences, killed around 4 thousand people and injured a further 10 thousand. Almost all buildings in the Historic Peninsula and Pera were damaged. The land and sea walls of Istanbul were demolished, as were the gates of Edirnekapi and Yedikule. Additionally, the earthquake destroyed the remains of the Constantine walls, the walls of Galata and the Galata Tower. The Hagia Sophia was largely unscathed, except for damage to its added minaret and mosaics. However, the Blue (Fatih Sultan Mehmet) Mosque suffered damage to its four central columns, its main dome, and its minarets. Topkapi Palace was partially destroyed. The aqueduct of Valens and the Dikilitas (the Obelisk of Theodosius) in the At Meydani (Hippodrome) were also demolished.⁵

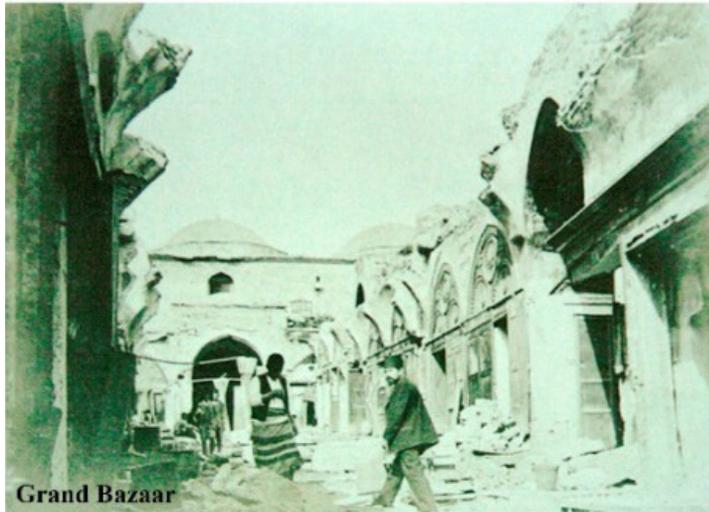
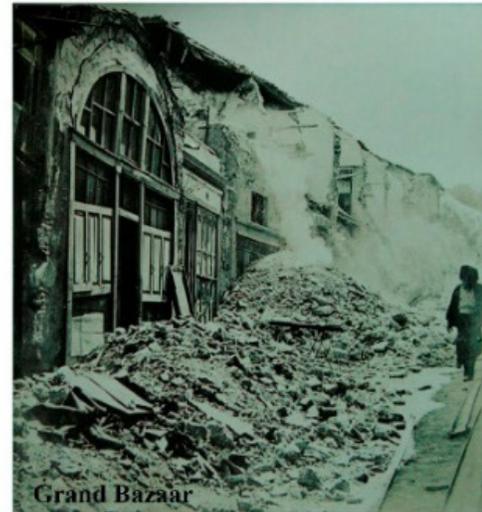
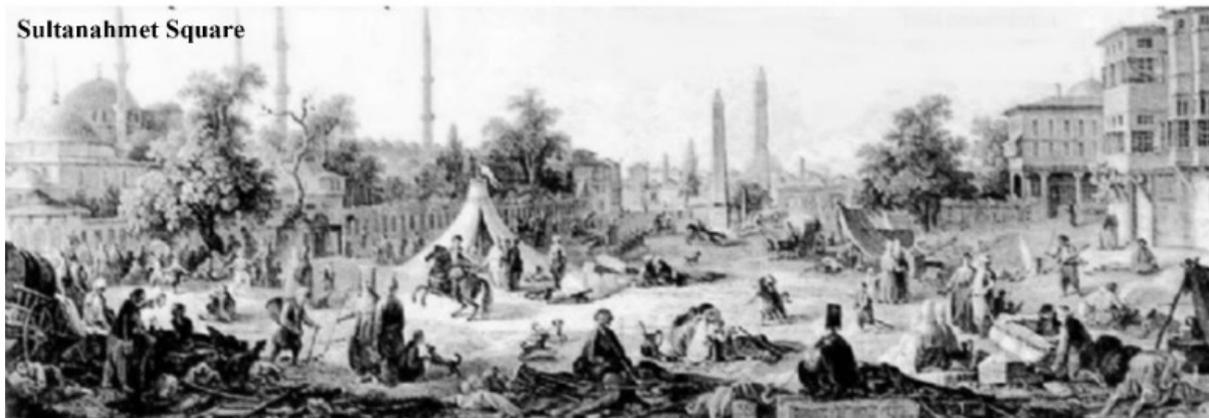
FIGURE 2 The earthquake of 1894. Damaged Historic Neighborhoods and Monumental Structures

On July 10, 1894, another destructive earthquake occurred in Istanbul. A significant amount of civil architecture was damaged (Figure 2).¹³ The Grand Bazaar was destroyed. Most of the Sirkeci railway terminal along with the Fatih, Besiktas, Aksaray, Edirnekapi, Topkapi, Balat, Bakirkoy and Silivrikapi neighborhoods were demolished. Over 2 thousand buildings were wrecked. After this earthquake, Sultan Abdulhamid II (1842-1918) appointed Demetrios Eginitis (1862-1934), the head of the Athens Observatory, to carry out post-disaster assessments.¹⁴ This investigation included a scientific report into the magnitude of the earthquake and the affected regions. The report also indicated that the Princes Islands were affected by the quake. In particular, the Ruhban Mektebi on Heybeli Island was demolished.¹⁵

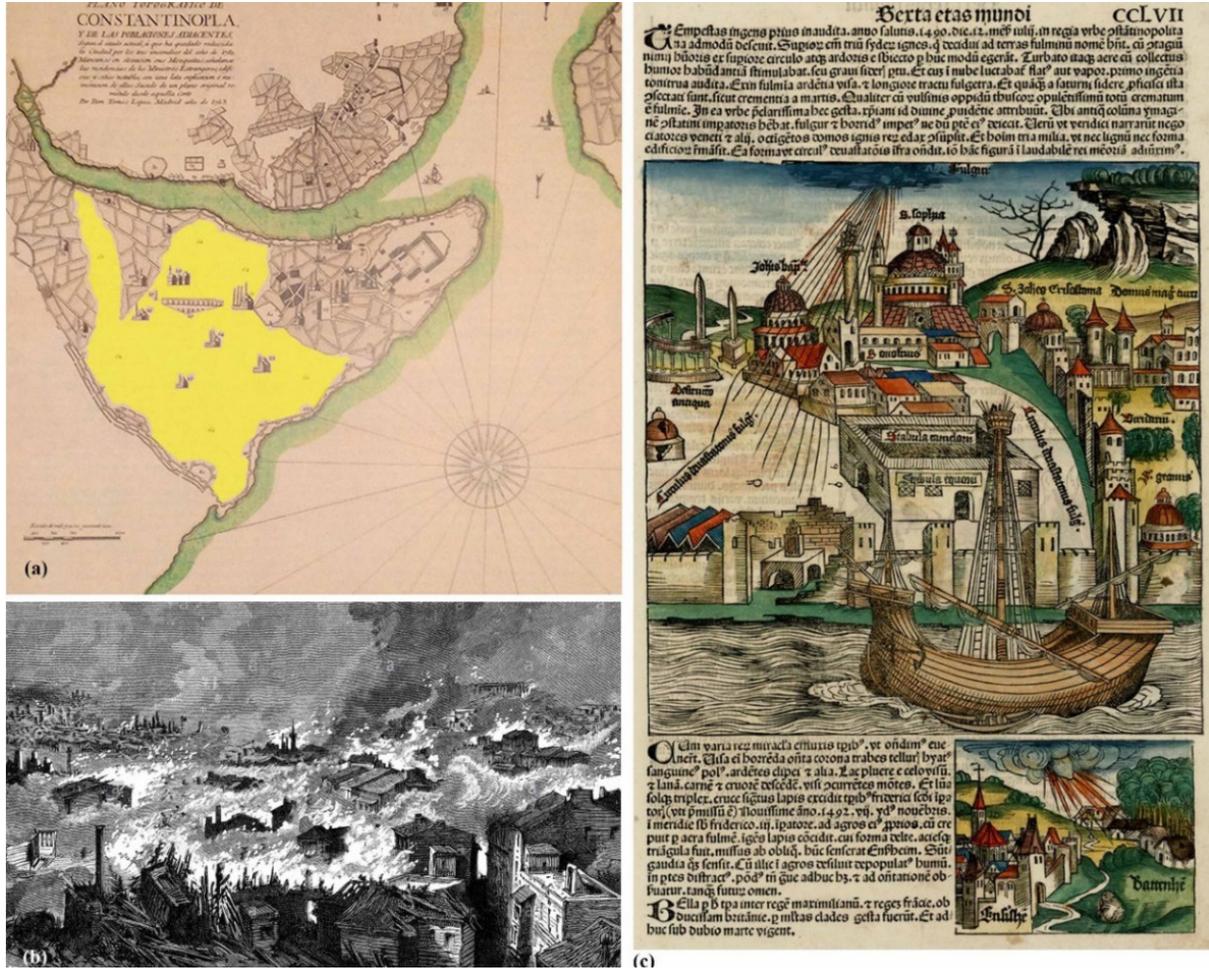
On August 22, 1782, a fire started in a house in a neighborhood near the Gul Mosque (Hagia Theodosia) in the Cibali district.¹⁹ It took sixty-five hours to extinguish. Over 20,000 houses and workplaces were destroyed, and people drowned in the Golden Horn and the Marmara Sea while attempting to escape from the flames. Previously, there had been a fire in Samatya on July 10, which damaged 1000 houses, and on August 21, 1782, a fire in the Balat district had spread to the Fener, Fatih, Edirnekapi and Yenibahce districts and burned approximately 7 thousand buildings to the ground. Spanish cartographer Thomas Lopes (1730-1802) indicated the losses from these three fires²⁰. Almost half of the city was destroyed (Figure 3).

FIGURE 3 (a) Thomas Lopez's Map – Ruined Districts in the Historic Peninsula of Istanbul indicated in Yellow (b) an Illustration by Deroy-Kohl after the fires of the 1780's, (c) Hartmann Schedel's Illustration, the Damaged Gungormez Mosque.

The findings of this study illustrate two main points. First, the historical maps of Istanbul include a broad range of information related to significant disasters. Thomas Lopes' maps and the illustrations of Hartman and Deroy-Kohl give some indication of the damage caused by disasters, and the insurance maps of Pervitich and Goads' illustrate the post-disaster situation. This evidence can be interpreted as proof that the impacts of disasters on city life and city structure were too high to be ignored. Second, the historical maps constitute contemporary, site-specific solutions and recommendations for the preservation of the authenticity of the city while reducing the after-effects of great disasters. The information from these historic plans and illustrations may assist in estimating the damage from future disasters and may contribute to scenario planning and mitigation studies.

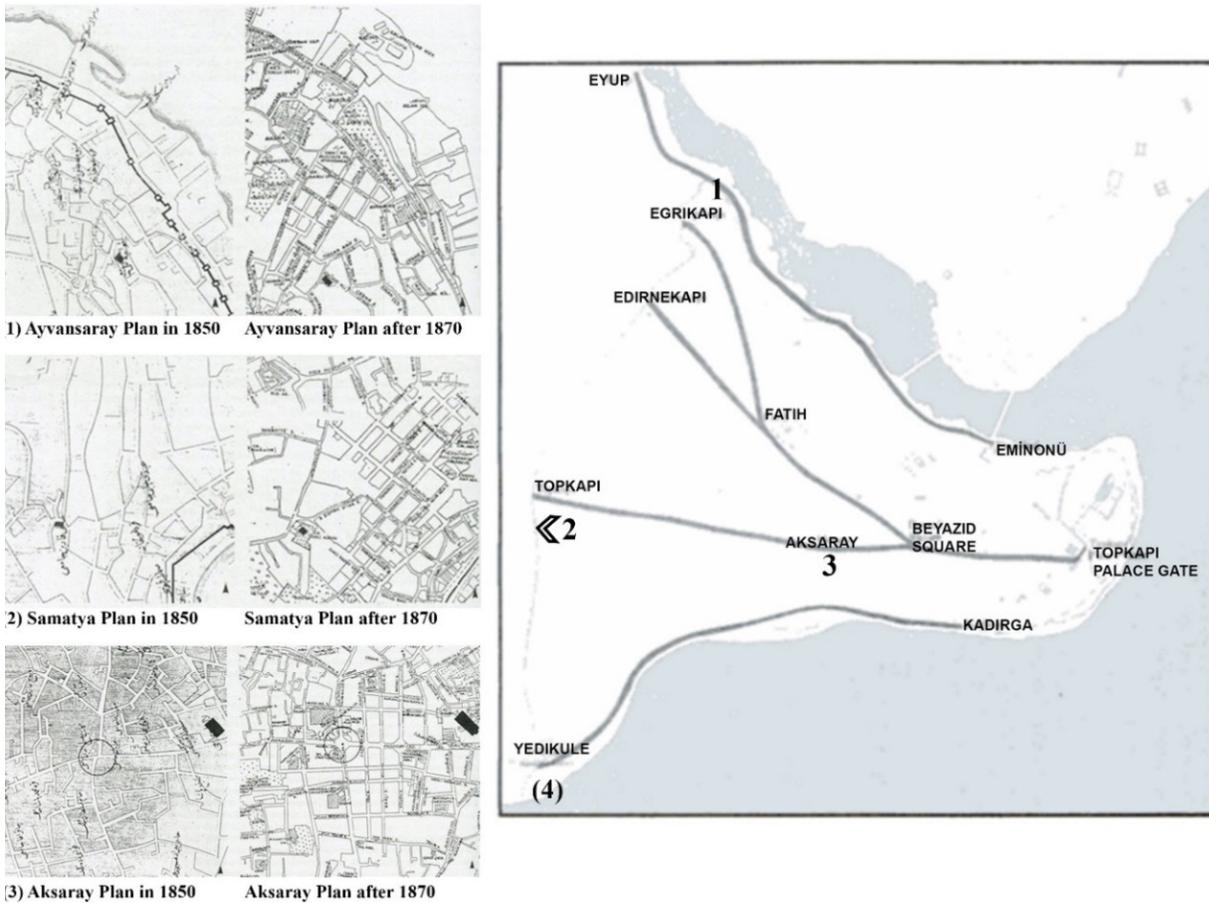
Helmuth Karl Bernhard Graf von Moltke (1800-1891) was commissioned to establish a street network for Istanbul by Sultan Mahmud II (1785-1839), and he completed the maps around 1839 under the reign of Sultan Abdulmecid (1823-1861).²³ Moltke's aim was to allow access from all popular neighborhoods and gates. The importance of eliminating dead-end streets and developing neighborhood squares to decrease the impact of fire were stated in the plan report (Figure 4). Even though Moltke's plan was not implemented, his proposed street pattern is still available.

FIGURE 4 Moltke's Plan, The Proposed Transportation Axes for The Historic Peninsula of Istanbul and The Urban Pattern Transformation with New Planning Approaches

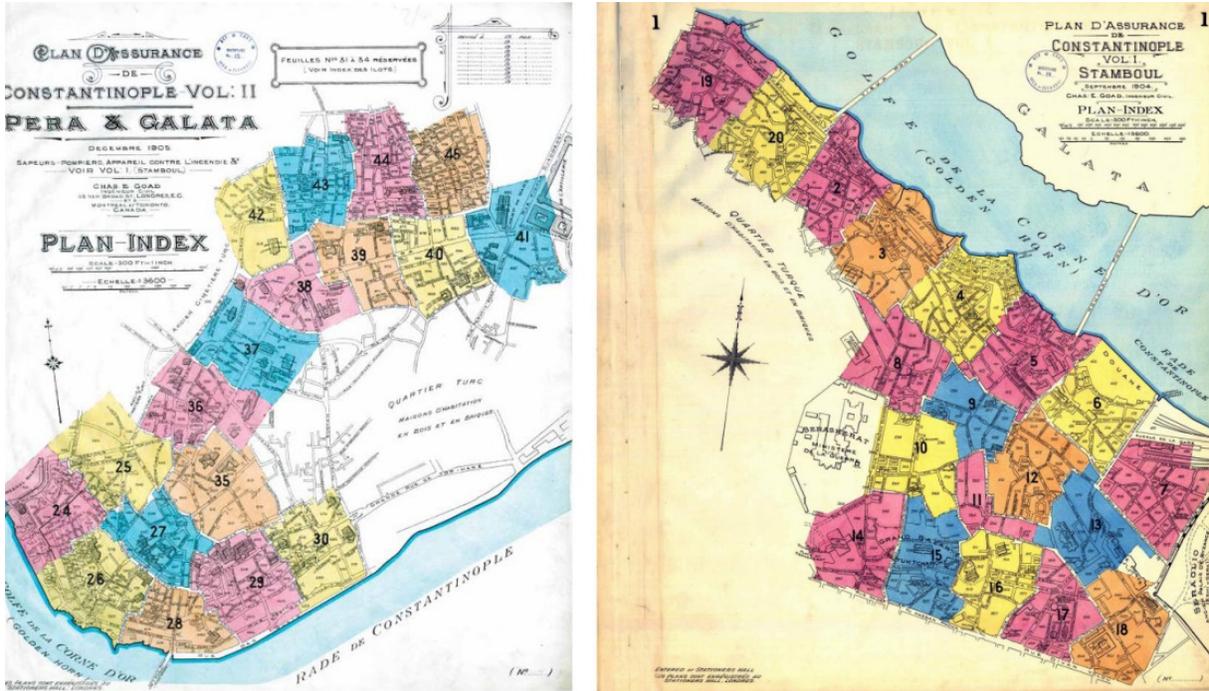
Insurance, which was then a common practice all over the world, started to be sold in Istanbul as a consequence of the economic collapse that follows a great disaster. Together with the effects of Westernization, several interactions were made with European countries to analyze the risks and results of disasters. After the 1870 fire, Charles Edouard Goad (1848-1910) developed a series of Istanbul fire insurance maps.²⁴ These are 1/600 scaled maps which consist of the functions, construction materials and sizes of buildings, the width of streets and the proximity of firefighting services and water supplies to estimate appropriate premiums (Figure 5). Existing gardens, market gardens, and historical structures were also included. These maps clearly indicate the urban development pattern and topography as well as the architectural pattern of the city.

FIGURE 5 Goad's Insurance Map for Galata, Pera and South of the Golden Horn, Fatih, Eminonu

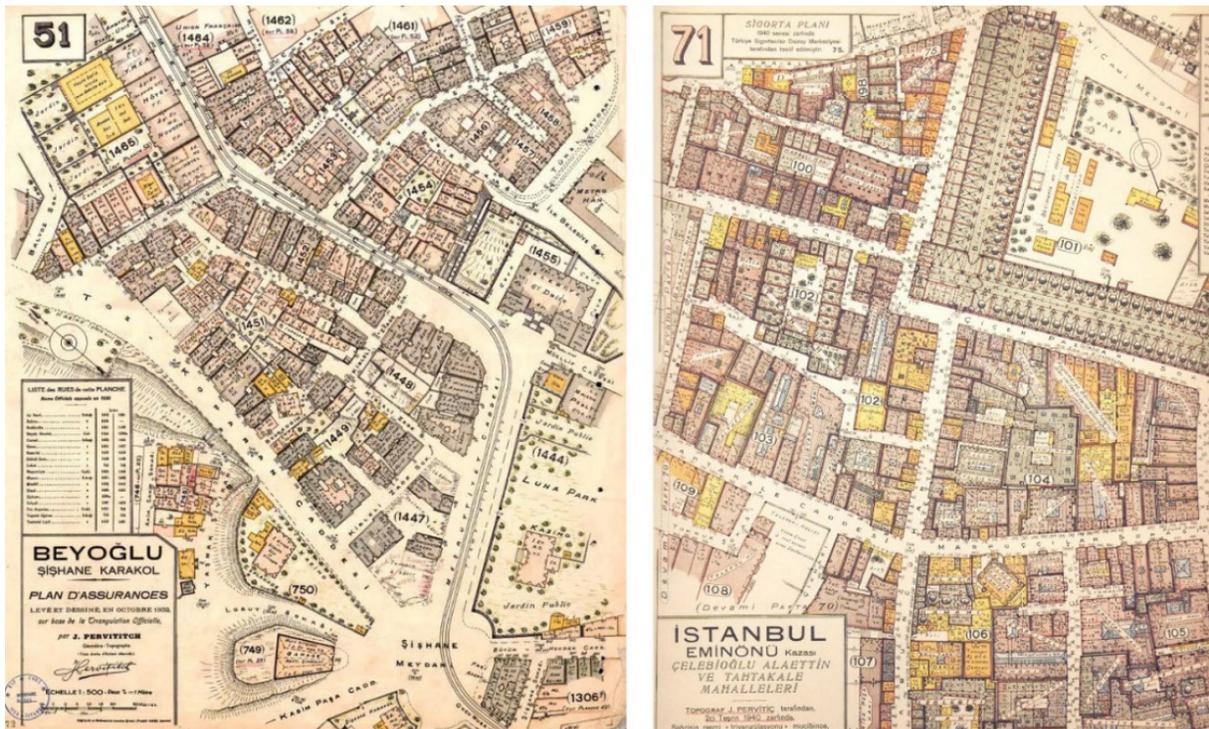
Great fires plagued Istanbul several times in the 1870s, which made it a profitable market for insurance firms. Jacques Pervittich (1877-1945) was one of the cartographers who surveyed Istanbul.²⁵ The resulting maps systematically covered every district of the Historic Peninsula, Uskudar, and Kadikoy.²⁶ Similar to the previous insurance maps, these plans indicate construction materials, proximity to water and open green spaces as well as the functions of buildings.²⁷ The plans were completed between 1922 and 1945 (Figure 6).

FIGURE 6 Pervititch's Insurance Plan for Beyoglu and Eminonu
