Geophysical monitoring of large-scale levee overflow experiments with electrical resistivity tomography

Abstract

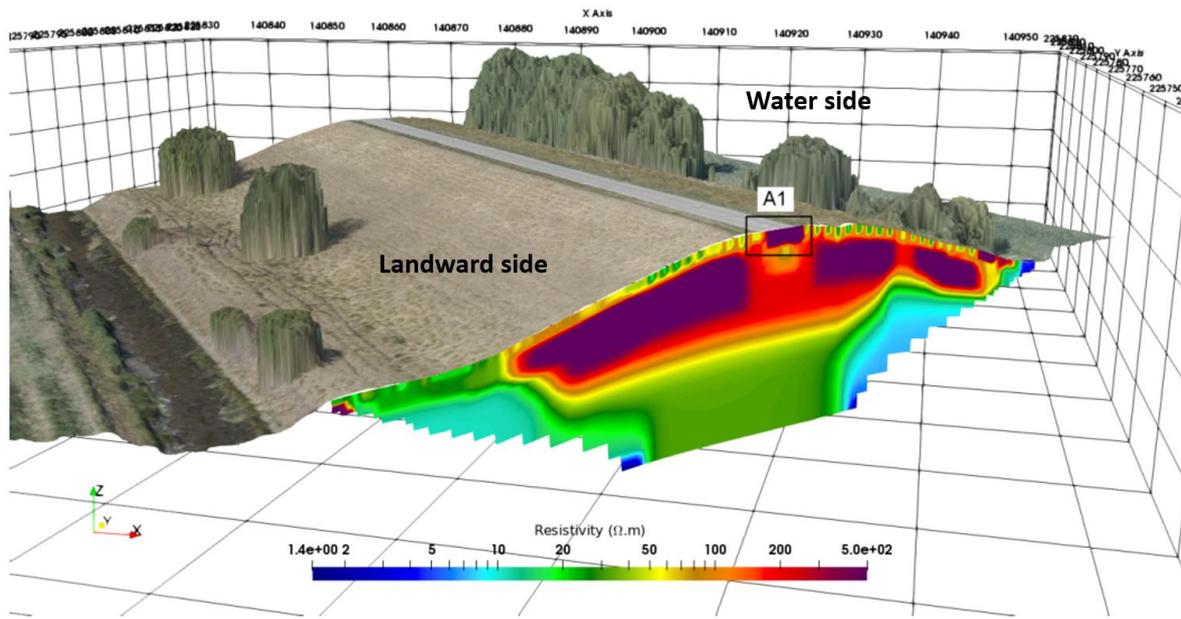
Figure 1: 2D-image of electrical resistivity integrated in a spatial elevation model of the Prosperpolder levee in Belgium. The colourbar indicates resistivity values. (Copied from: Antoine et al., 2022 with the authors’ consent).

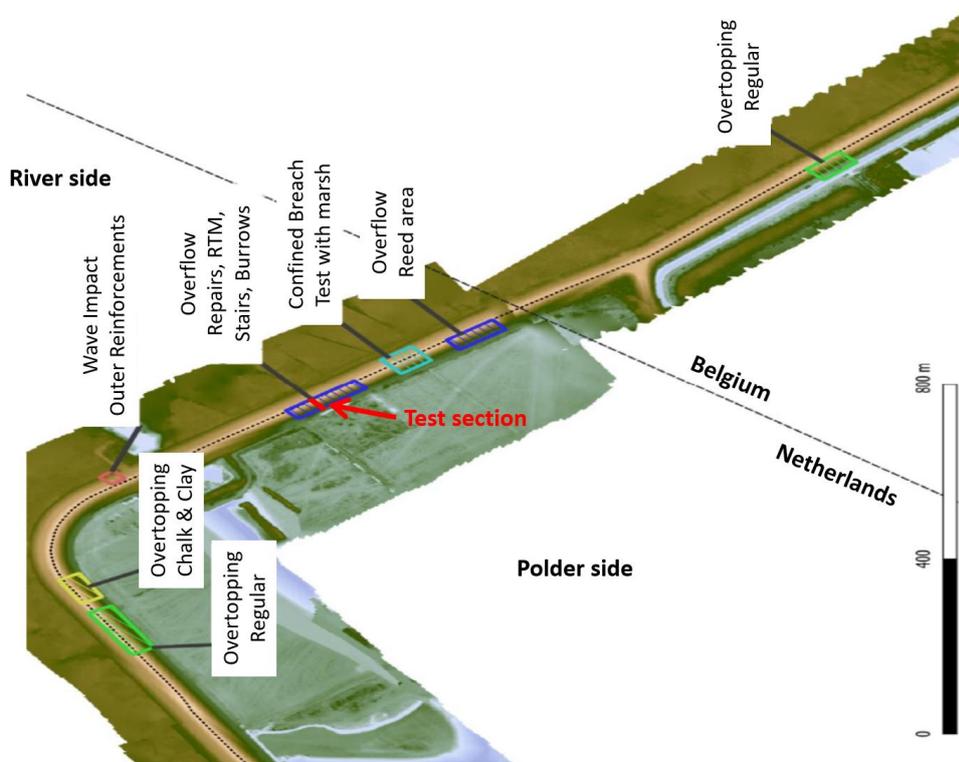
Figure 3: Digital terrain model of the Living Lab Hedwige Prosperpolder highlighting the large-scale levee stress tests from Polder2C's second experimental season. The specific test section with ERT installation is marked in red (Adapted from: Depreiter & Peeters, 2021).

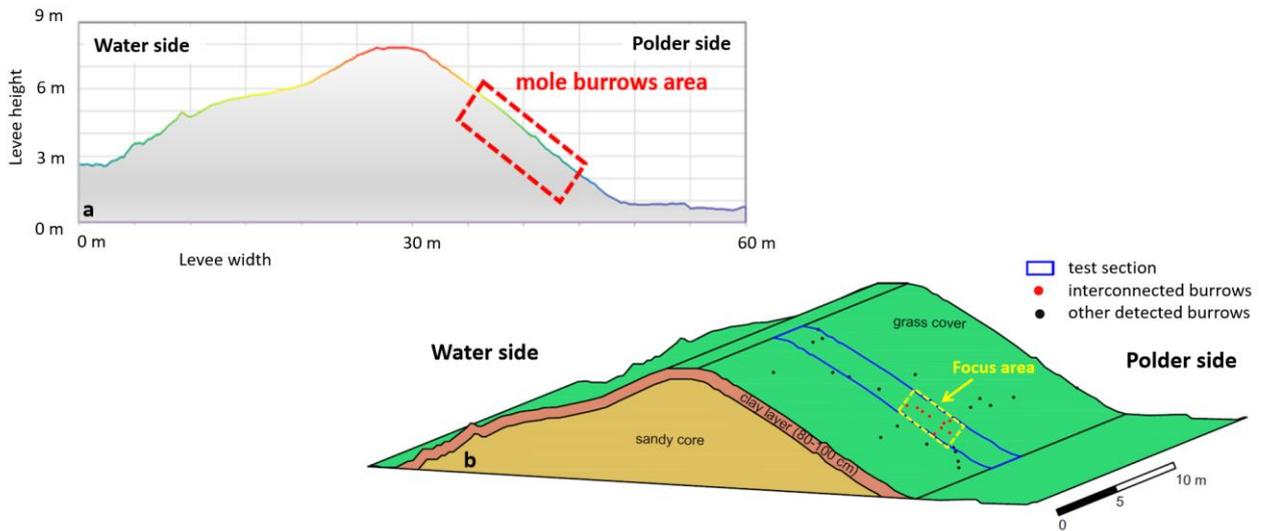
Figure 4: Levee cross-section at the test location in 2D and 3D featuring the cross section geometry and materials, the spread of mole and vole burrows on a levee stretch of 20m, the interconnected mole burrows and the test section. The colours at the outline of the 2D cross-section correspond to the levee height.

Given the available ERT measurement equipment, and in particular the available number of sensor and the length of cables (see also sections 3.2 and 3.3), the part of the test section with interconnected burrows was prioritized as a focus area for the ERT monitoring.

For this specific experiment, the flume was installed with a width of 2 m (see exact position in Figure 4b). This was a standard width that was used in the majority of Polder2C’s experiments. Since the primary goal of the overflow experiment was to test the feasibility and effectiveness of a low-cost emergency measure against surface erosion, a part of the focus area within the flume was covered with road plates. In particular the road plates were installed in a configuration that covered all the interconnected mole burrows. To enable ERT measurements at the same location, synthetic road plates were applied instead of metal ones. This was necessary as metal objects can undermine the quality of ERT imaging. A clear practical advantage of these synthetic road plates when used as an emergency measure is that they are much lighter than metal ones, allowing to have them placed by two people without the need of additional heavy equipment. This makes them easily deployable in various locations even under adverse weather conditions. The road plates were fixed on the slope by metal pins. Their exact positioning and configuration in the flume is shown in Figure 7.

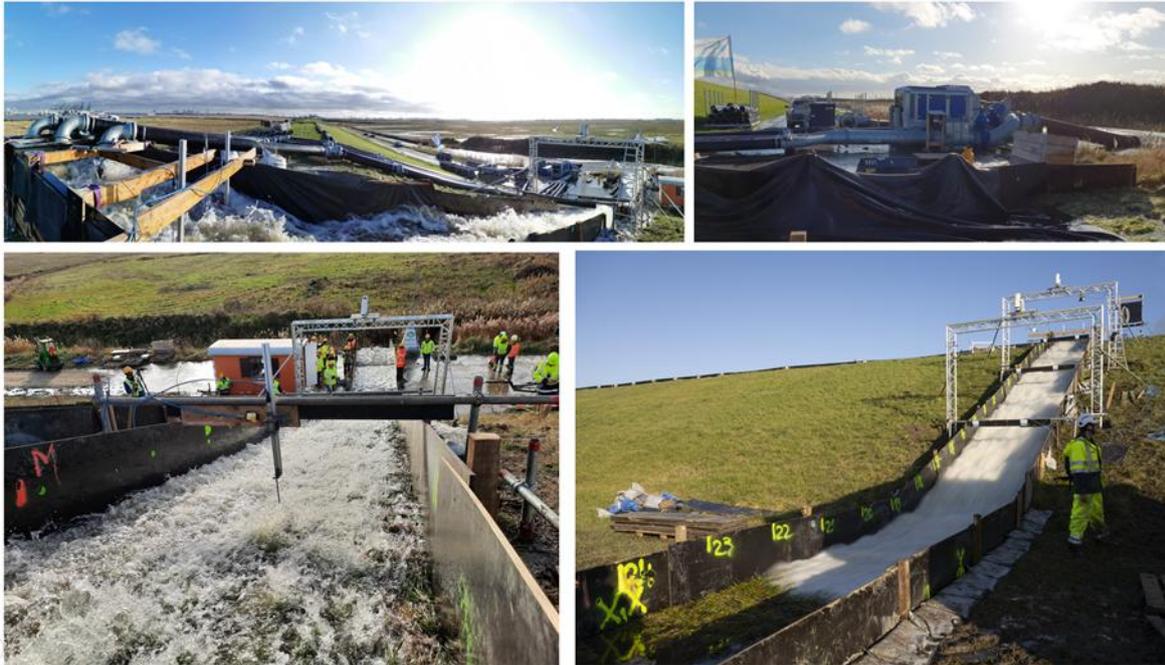
Figure 5: Impressions of the various components of the overflow generator (Source: Polder2C’s archive, www.polder2cs.eu).

The overflow generator developed by Flanders Hydraulics Research forms the basis of the experimental setup. This has been designed to uniformly distribute water over a dike crest for overflow experiments. It consists of three components made of high-density polyethylene, a base, a reservoir, and a bridge. Their compact shapes and lightweight material allow for easy transport and assembly. Water is pumped through an inlet structure into the generator, where it flows over a bridge onto the dike crest and down a flow canal lined with coated hardboard plates. Sensors and cameras monitor the experiments (see also Figure 5). This system allows flows up to 66 m³/min over a 2 m wide section, which equals to 33m³/min/m or 0.55m³/s/m. To prevent water leakage and erosion during testing, EPDM sheets and sandbags are applied at vulnerable spots. For a detailed description of the overflow generator, the reader is referred to Koelewijn et al. (2022).

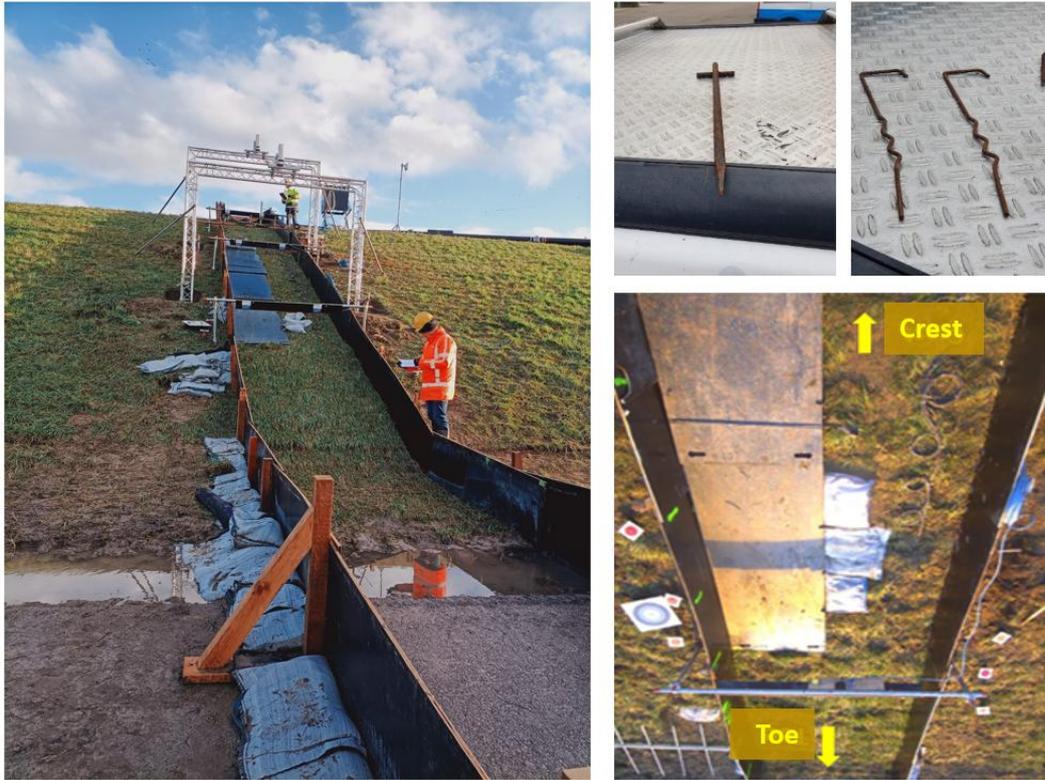
Figure 6: Impression of the location and configuration of the road plates in the flume and the types of pins that were used for their attachment to the ground (Source: Tsimopoulou & Koelewijn, 2023).

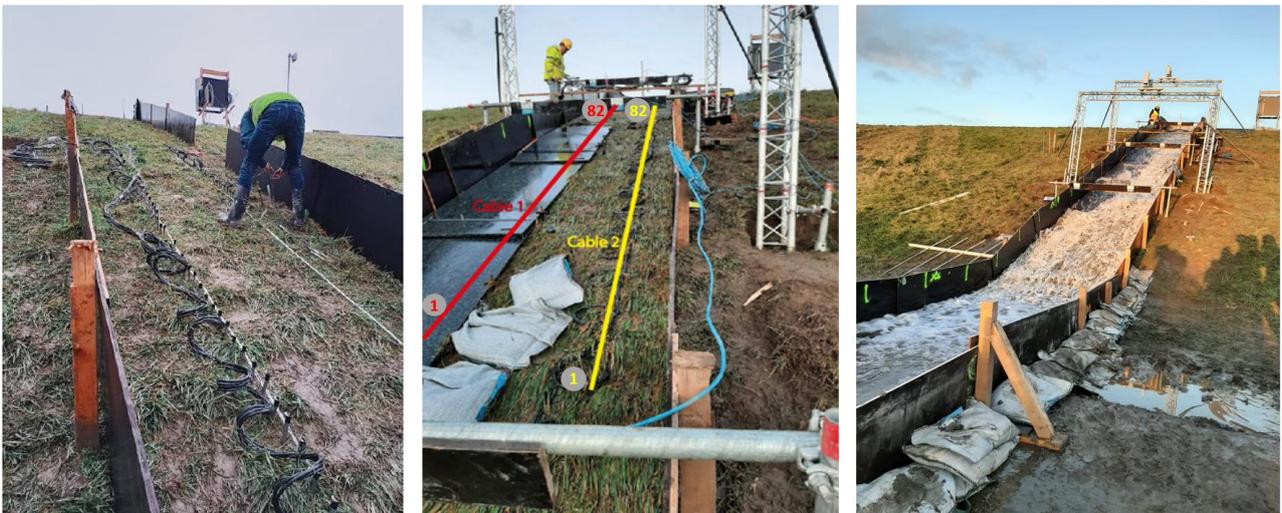
Figure 7: Installation of the second ERT cable (left), configuration on the slope during no-flow period (middle), flow in the flume (right).

To measure and monitor the changes in the subsurface during overflow, two parallel cables were installed on the slope of the levee, see Figure 7 (left). The installation of the electrodes was planned to match the interconnected mole burrows. Since the area of interconnected mole burrows was selected as the most interesting for the subsoil measurements, it was deemed suitable to place the ERT electrodes as close as possible to the cavities, hence underneath the road plates, which were meant to cover the cavities in any case. For this reason the ERT electrodes were installed in the flume prior to the application of the road plates. Cable 1 was covered by the synthetic road plates, while cable 2 was on open soil. The main goal was to measure below the plates, and cable 2 was installed mainly as a backup in case cable 1 failed. From cable 2 data were collected only before and after the end of the experiment. This choice was purely dictated by the acquisition time required for each measurement. Doubling the number of pins would approximately double the acquisition time, as the time depends heavily on the array used and the number of deployed pins. To achieve the highest frequency of measurements during the overflow experiment, we prioritized cable 1.

164 electrodes were utilized in total with 10 cm long stainless steel pins pushed into the ground, see Figure 7 (left). The cables used in this experiment were developed by Deltares. The exact cable configuration and their connection to the data acquisition system is illustrated in Figure 8. The measuring array was optimized for short time acquisition, and it contained a selection of dipole-dipole array and gradient array. The electrode spacing was 10 cm, yielding a horizontal resolution of at least 5 cm. This means that the smallest geological structure or resistivity anomaly that can be accurately detected and represented in the resulting model is approximately 5cm. The optimization is based on the sensitivity matrix, which means that only the best measurements were kept for each discretization cell.

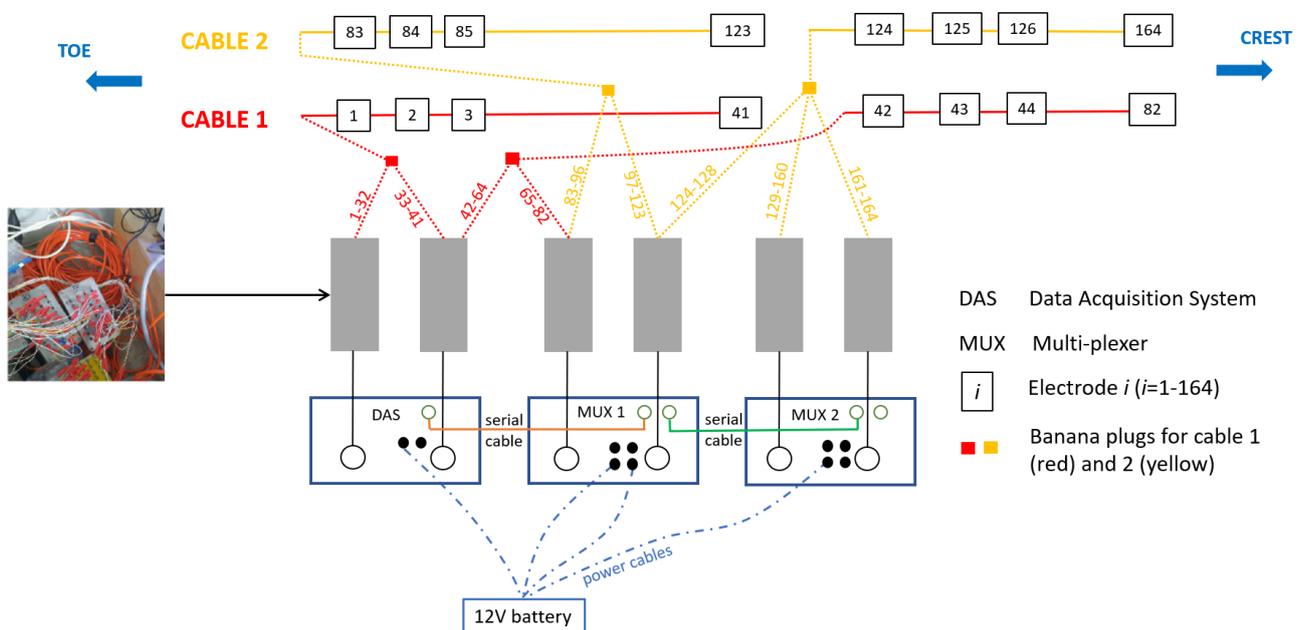
Figure 8: Detailed sketch of cable configuration used in this experiment and their connection with the data acquisition system.

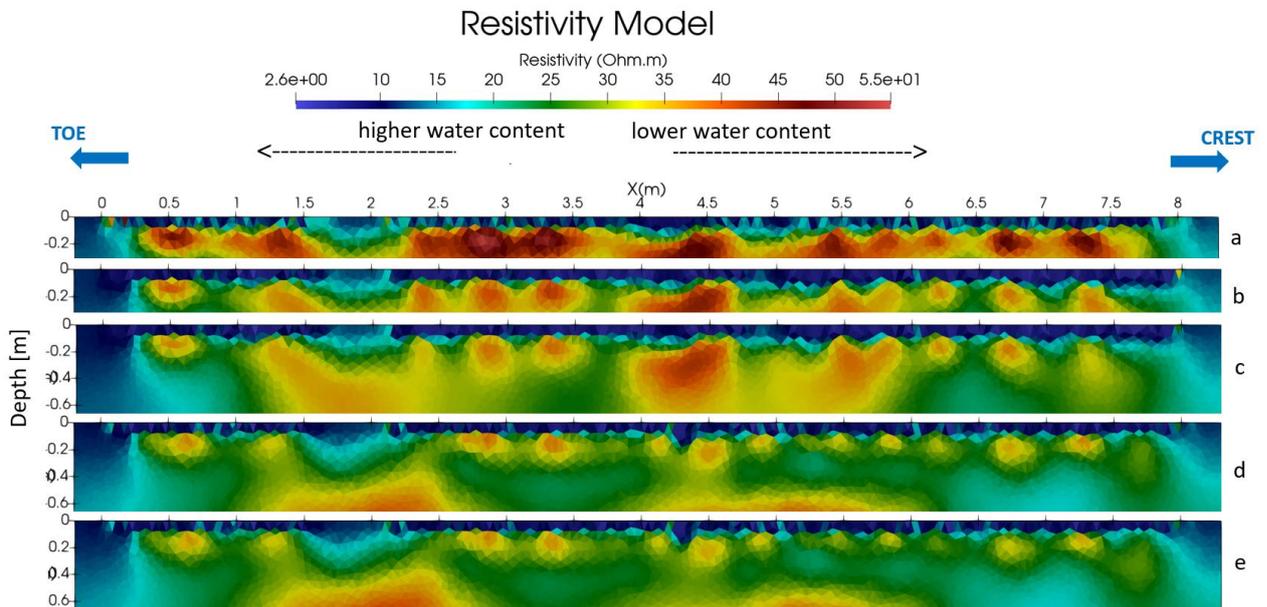
Figure 9: Recorded resistivities from cable 1 before initiation of testing (a) and after completion of experiments 2 (b), 3 (c), 4 (d) and 5 (e).

In all graphs of Figure 9, the top 10 cm of soil consistently show very low resistivity, indicating a layer of clay with high water content close to the surface, even before the experiment began. This is reasonable due to the rainy weather in the days leading up to the test. Pictures taken during the installation of the ERT electrodes (Figure 7, left) clearly show a wet levee slope with visible muddy patches, confirming these conditions. After the first overflow run (Figure 9b), the resistivity value below the surface layer drops significantly, indicating a highly saturated layer that remains waterlogged throughout the subsequent test runs (Figure 9c to 9e).

A notable feature in the resistivity scans, particularly in the 10–35 cm depth range, is the appearance of high resistivity values. In the pre-experiment scan (Figure 9a), the highest resistivity values in this depth range are observed at specific locations along the X-axis: $X = 0.5$ m, 1.3–1.5 m, 2.3–3.5 m, 4.3–4.5 m, 5.5 m, 5.7 m, 6.2 m, 6.7 m, and 7.3 m. These locations and depths align with the positions of mole burrows identified through ground-penetrating radar and visual probe inspections. Therefore, it is reasonable to conclude that these high resistivity areas represent the air-filled cavities of the mole tunnels. After each consecutive experiment, the resistivity at these spots gradually decreases, suggesting that water is infiltrating and filling the tunnels, possibly, some collapse has also taken place.

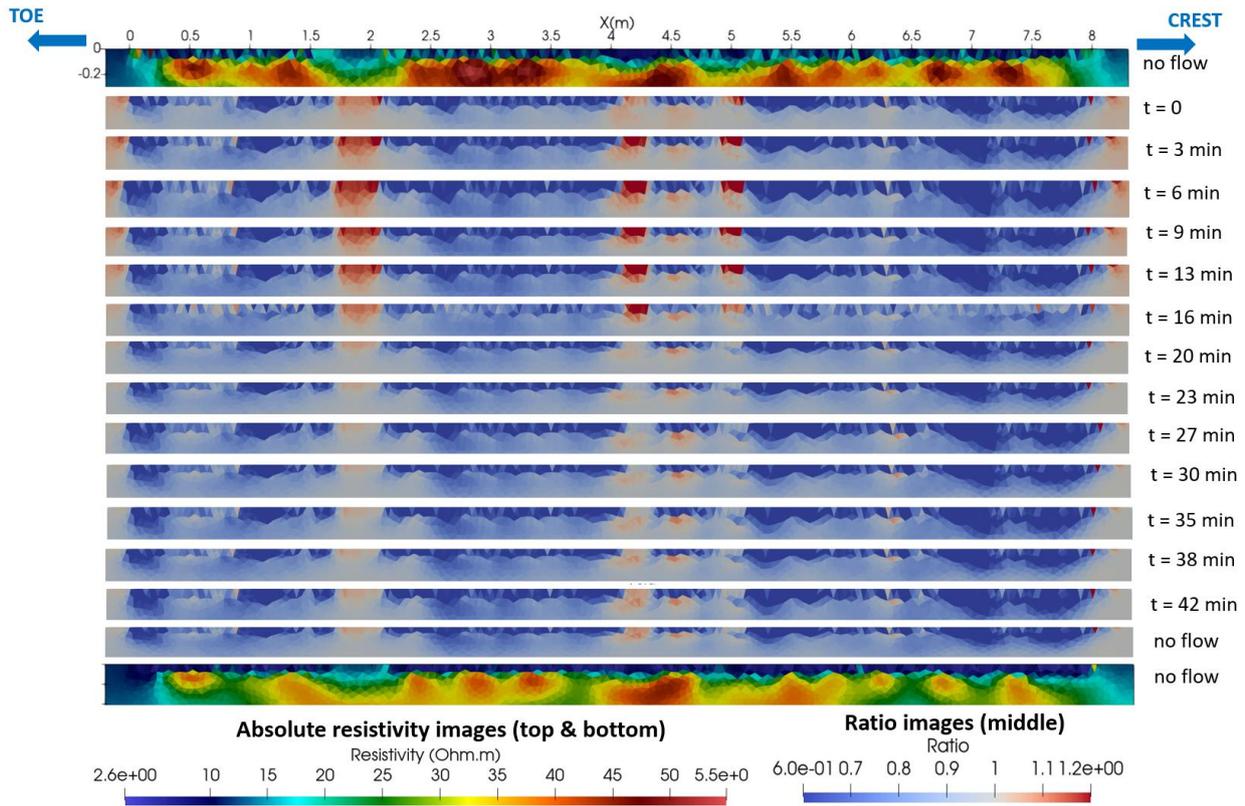
Figure 10: Measurements for experiment 2, cable 1.

In Experiment 2 (Figure 10), the initial overflow run with the lowest flow discharge of $q=5.6$ m³/min, the resistivity ratio images from $t=0$ to $t=16$ minutes reveal a significant increase in resistivity at specific locations: $X=1.7$ –2.1 m, $X=4.1$ –4.3 m and $X=4.9$ –5.1 m. These regions appear red on the images, indicating the development of new voids adjacent to the pre-existing mole cavities. From $t=20$ minutes onward, however, the red colour fades in these areas, suggesting that the initial void formation process gradually reverses, allowing soil to refill these spaces. This phenomenon is corroborated by the final absolute resistivity values after the flow ceases, as minimal resistivity changes are observed in the same locations, confirming that the voids largely fill back in.

In contrast, across the remaining lengths of the scanned surface, specifically at locations $X=0$ –1.7 m, $X=2.1$ –4.1 m, $X=4.3$ –4.9 m and $X=5.1$ –8 m, the blue coloration dominates from start to finish, indicating increased water content throughout these regions. Comparing these water-saturated areas with the absolute resistivity values prior to the flow (shown in the top image of the figure), the darkest blue regions are observed around the peripheries of the pre-existing mole cavities described in Section 4.1, while the cavities themselves appear pale blue. This pattern indicates that infiltration occurs primarily around the cavities, while the cavities themselves remain relatively intact, with only small amounts of water infiltrating them.

In the early experiments (2 and 3), resistivity ratio images revealed the formation of new voids adjacent to pre-existing mole cavities, evidenced by the appearance of red regions in the images that indicate increased resistivity. However, at Experiment 2, as the experiment progressed, the newly formed voids were gradually filled with water and soil particles, as reflected in the transition from red to grey hues. This transition suggests that under moderate flow discharges ($\leq 5.8 m^3/min$), the soil retained the capacity to refill voids with infiltrating water and soil particles, preventing extensive void expansion.

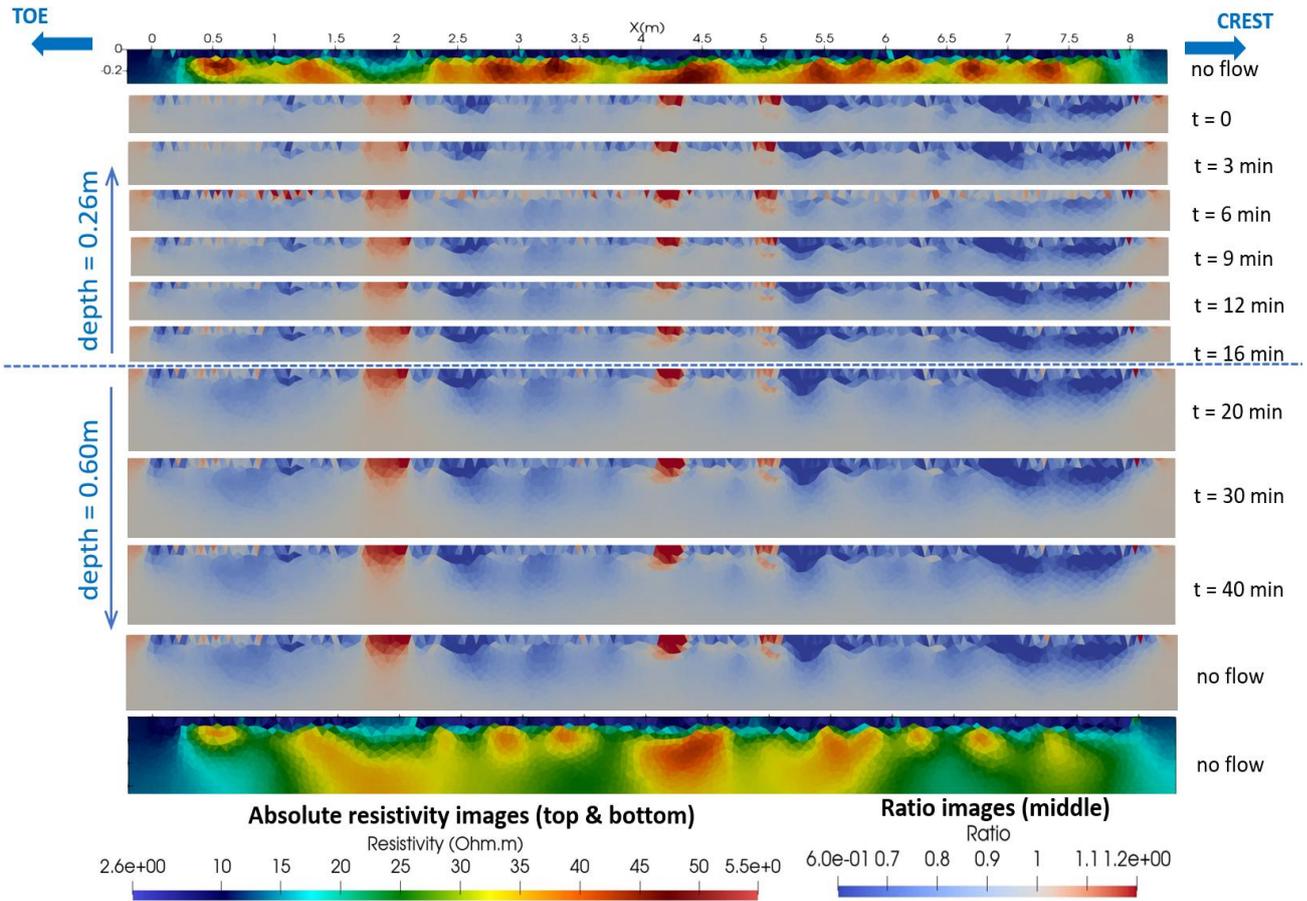
Figure 11: Measurements for experiment 3, cable 1.

Experiment 3 (Figure 11), conducted on the same day with a slightly increased flow discharge of $q=5.8 \text{ m}^3/\text{min}$, largely replicates the patterns observed in Experiment 2, with minor differences. Here, red regions reappear at the same locations where new voids developed in Experiment 2, but this time, these red areas persist through the end of the experiment, indicating that the voids remained open after reforming. As in Experiment 2, the darkest blue regions appear adjacent to the pre-existing cavities, while the cavities themselves display a gray (e.g., $X=4.3-4.6 \text{ m}$) or pale blue (e.g., $X=7.3 \text{ m}$) hue. In the former, this shows the cavities remain intact, whereas the latter suggests gradual filling with soil particles, likely driven by the pressure exerted by water-saturated soils in adjacent areas toward these lower-pressure cavities.

A novel phenomenon observed in Experiment 3 is the appearance of high-resistivity spots near the surface in the $t=6 \text{ min}$ ratio image, at locations $X=0.3-1.5 \text{ m}$, $X=2.5-2.7 \text{ m}$, $X=3.5-4 \text{ m}$ and $X=6.3-8 \text{ m}$. These spots gradually diminish in subsequent images, indicating initial surface erosion likely due to the formation of small voids as surface grass is uprooted or displaced. Notably, no significant resistivity changes were recorded at greater depths after switching to the ‘deep’ data acquisition protocol at $t=20 \text{ min}$, indicating that, at this moderate flow discharge of $5.8 \text{ m}^3/\text{min}$, the overflow test had minimal impact on deeper zones.

The surface erosion observed in Experiments 3 and 4, indicated by high-resistivity spots near the surface, is another key process influenced by flow discharges. The formation of small voids near the surface, likely caused by the uprooting of surface vegetation and displacement of soil, was a recurring phenomenon in these experiments. The gradual disappearance of these spots over time suggests that surface erosion occurs rapidly at the onset of high-flow events but stabilizes as surface materials are either eroded or compacted. In contrast, deeper subsurface changes, particularly void expansion, were more persistent under higher flow conditions, as seen in Experiment 4, where new voids continued to develop throughout the experiment.

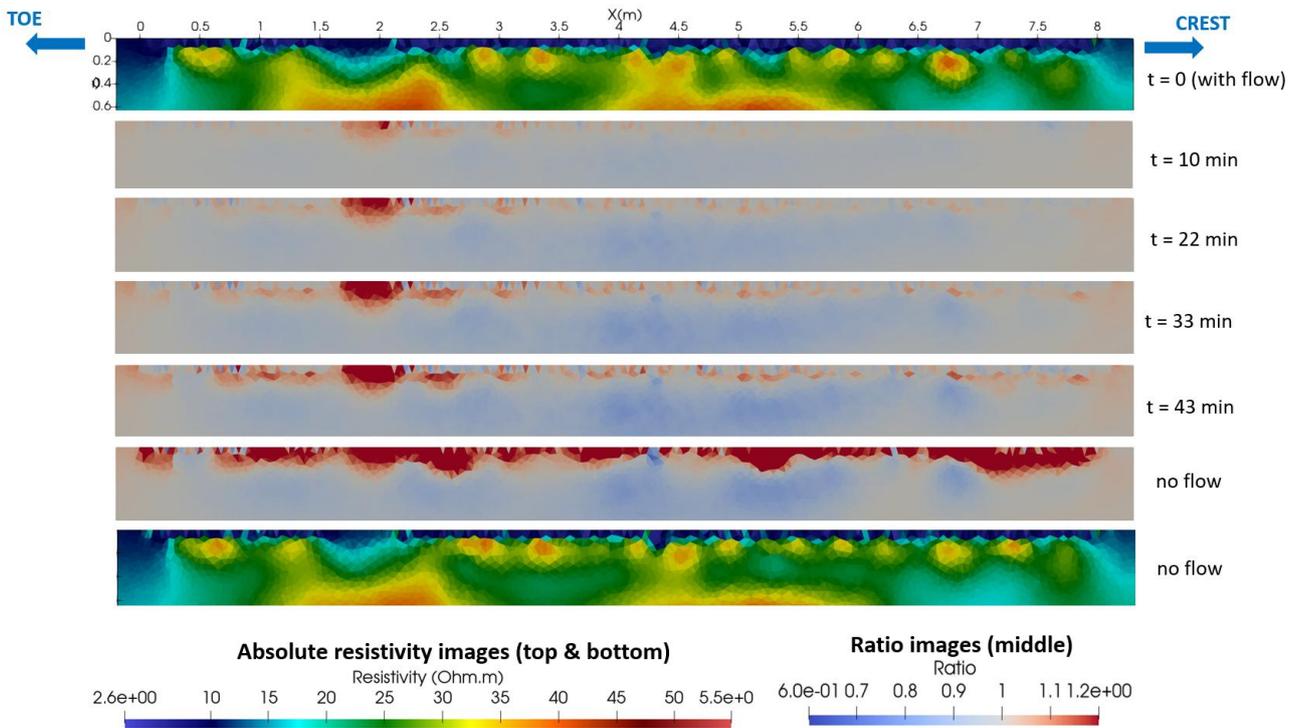
Experiment 4 (Figure 12) was conducted three days after Experiment 2, with an increased flow discharge of $q=9 \text{ m}^3/\text{min}$. Unlike previous experiments, baseline resistivity values were not recorded before flow initiation due to measurement oversight, so ratio images in Figure 12 use the resistivity values at $t=0 \text{ min}$, just after flow started on the levee slope, as a reference. This adjustment leads to notable differences in resistivity patterns compared to Experiments 2 and 3, as well as Experiment 5 that will be described later in this section.

At $t=0 \text{ min}$, absolute resistivities in the areas of pre-existing cavities range from $32\text{--}40 \text{ }\Omega\cdot\text{m}$, considerably lower than in the pre-flow images from Experiments 2 and 3. This indicates that infiltration had already occurred, filling these cavities with soil particles and water prior to the first measurement in Experiment 4.

A key feature of Experiment 4’s ratio images is the pronounced red coloration across the graph, while blue areas remain faint and limited, suggesting minimal additional water content increase in the subsoil throughout the experiment. Pale blue patches begin to emerge at $t=22 \text{ min}$ and gradually intensify at a slow rate until the end of the experiment. In contrast to Experiments 2 and 3, these patches extend through the entire depth of the focus area, including depths of $0.26\text{--}0.6 \text{ m}$, indicating that at this higher flow discharge, deeper infiltration occurs. This trend was absent in the earlier experiments where flow discharges were lower.

While void formation patterns in Experiment 4 align only partially with those observed in Experiments 2 and 3, some similarities are present. In Experiments 2 and 3, voids appeared consistently at $X=1.7\text{--}2.1 \text{ m}$, $X=4.1\text{--}4.3 \text{ m}$ and $X=4.9\text{--}5.1 \text{ m}$. In Experiment 4, however, only the void at $X=1.7\text{--}2.1 \text{ m}$ reappears, starting at $t=10 \text{ min}$. Additionally, similar to Experiment 3, red spots emerge at the top layer of the subsoil from $t=10 \text{ min}$, upstream of the void formation,

specifically at $X=2.1-3.2$ m. These spots gradually spread across the top layer, likely signaling surface erosion initiation as observed in Experiment 3.

At the end of Experiment 4, a marked resistivity increase occurs across the entire top layer when the flow ceases. This sharp rise suggests a rapid transition in the top layer, as water-filled gaps created under high pressure are quickly replaced by air, likely due to the drop in pore pressure post-flow.

Figure 12: Measurements for experiment 4, cable 1, with a reference point for the ratio images after the flow started.

The results of Experiments 4 and 5, conducted with higher flow discharges (9 and $12 m^3/min$), further illustrate the influence of hydraulic conditions on subsurface processes. In Experiment 4, the increased flow discharge led to deeper infiltration, as seen in the resistivity changes extending to depths of 60 cm. The pronounced red coloration across the ratio images indicates substantial void development at both shallow and deeper depths, suggesting that higher flow discharges increased pore pressures, driving the formation of new cavities and the expansion of existing ones. Additionally, the appearance of red spots near the surface aligns with surface erosion processes, likely initiated by water displacing surface materials and uprooting vegetation. It is noted that the area was covered with road plates, which in principle are expected to have reduced the intensity of erosion, both internal and on the surface.

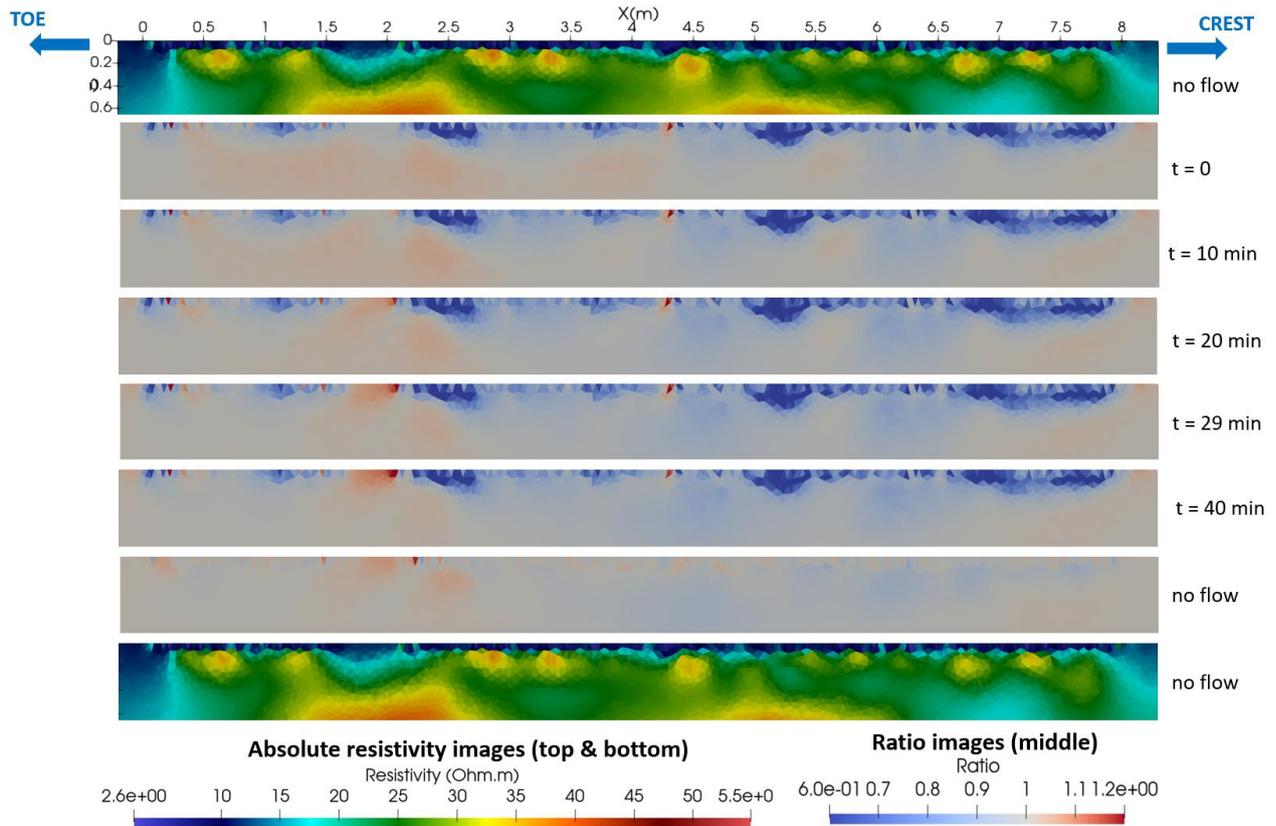
Figure 13: Results of ERT experiment 5, cable 1.

Experiment 5 (Figure 13), conducted immediately after Experiment 4, used the highest flow discharge achievable by the pumping system ($q=12$ m³/min). Having as a reference a state of non-flow, the results appear notably different than those of Experiment 4 despite the fact that both experiments used much higher flow discharges than experiments 2 and 3. Unlike Experiment 4, where void creation dominated the resistivity patterns, Experiment 5 is characterized by prominent infiltration across the subsurface.

In the ratio images, blue spots indicating increased water content are clearly visible in the top layer of the subsoil. Dark blue regions are particularly pronounced at locations $X=2.3-2.7$ m, $X=4.7-5.4$ m and $X=6.7-8$ m, all of which correspond to pre-existing voids. Specifically, the regions at $X=2.3-2.7$ m and $X=4.7-5.4$ m align with pre-existing mole cavities, while the region at $X=4.7-5.4$ m coincides with the location of a newly formed void from the first experiment. The low resistivity values of these dark blue spots suggest that the voids have become filled with water in this experiment, confirming ongoing infiltration.

It is noted that the ratio images remain almost unchanged throughout the course of Experiment 5. The only significant alteration is the appearance of a small red spot at $X=2.1$ m, indicating a slight expansion of nearby cavities. This overall stability may suggest that the slope has reached a temporary equilibrium, where further significant changes in the subsoil conditions could only occur with a sudden shift in flow discharge or a considerable extension of the experiment duration. This hypothesis warrants further investigation into the internal erosion processes to better understand the long-term behaviour of such systems. Among others it needs to be investigated whether the road plates that were installed on the top of cable 1 played a role in reaching this temporary equilibrium, by reducing the flow on the soil surface and the flow velocities.

Experiment 5, conducted immediately after Experiment 4 at the maximum achievable flow discharge, exhibited a contrasting pattern. Rather than further void formation, the ratio images indicated widespread infiltration across the subsurface, with prominent blue regions corresponding to increased water content within pre-existing cavities. The stability of the ratio images throughout this experiment suggests that the soil had reached a state of equilibrium, where further significant changes in subsurface conditions could not be induced without altering the flow discharge or extending the experiment's duration. This stability highlights the potential for a self-limiting erosion process under certain hydraulic conditions, where water-filled voids resist further expansion due to reduced pore pressure gradients.

The consistent resistivity patterns observed in Experiment 5, along with the limited changes in subsurface conditions, suggest that the levee slope may reach a temporary state of equilibrium under sustained high-flow conditions. This finding raises important questions about the long-term stability of such systems. However, this finding is influenced by the presence of road plates, which significantly reduce the direct flow on and into the soil. The road plates lead to lower flow velocities and, consequently, much less erosion compared to scenarios without such protection. Without the road plates, we would expect higher velocities and increased erosion, potentially altering the observed resistivity patterns and stability outcomes. This highlights the critical role of surface protection in mitigating erosion processes. While short-term experiments may show minimal changes after a certain threshold, prolonged exposure to high flow discharges or intermittent flow events could lead to gradual weakening of the subsurface, especially if voids remain partially filled with air, as seen in some regions of the levee. Further investigation into the long-term behavior of internal erosion processes, especially under varying protective conditions, is necessary to better understand the thresholds at which sudden structural failures may occur.
