# Internal Erosion in a Full-Scale Experimental Embankment Dam: Insights from the Dismantling of the Älvkarleby Test Dam

## Abstract

# 1 Introduction

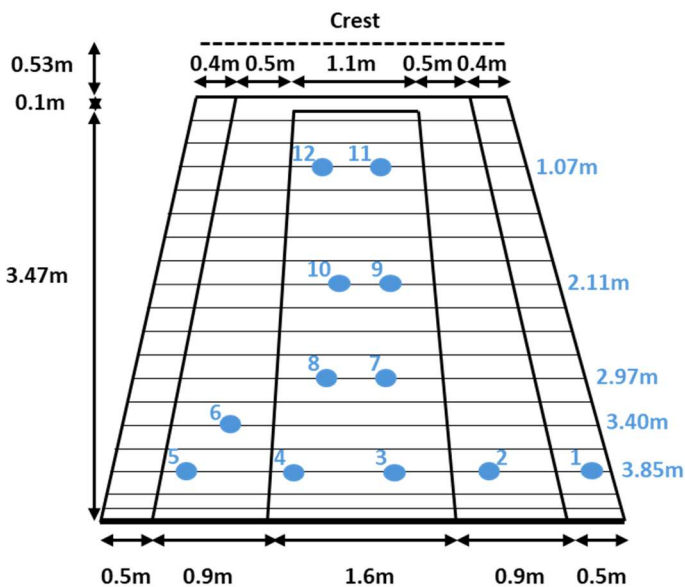
The piezometers were installed in one single section of the dam, 3 m in from the right abutment. Their installation depths and locations within this section is shown in Figure 6. Eleven of the twelve piezometers installed in the core and filter zones were recovered and found to have settled from their original installation depths. Settlements ranged from approximately 5 to 10 cm, with the biggest relative movements in the lower core and the largest total settlements at the top, see Table 1.

Figure 6. Location and approximate depth of the 12 piezometers installed in one section of the dam, 3.0 m in from the right abutment. Upstream to the left and downstream to the right.

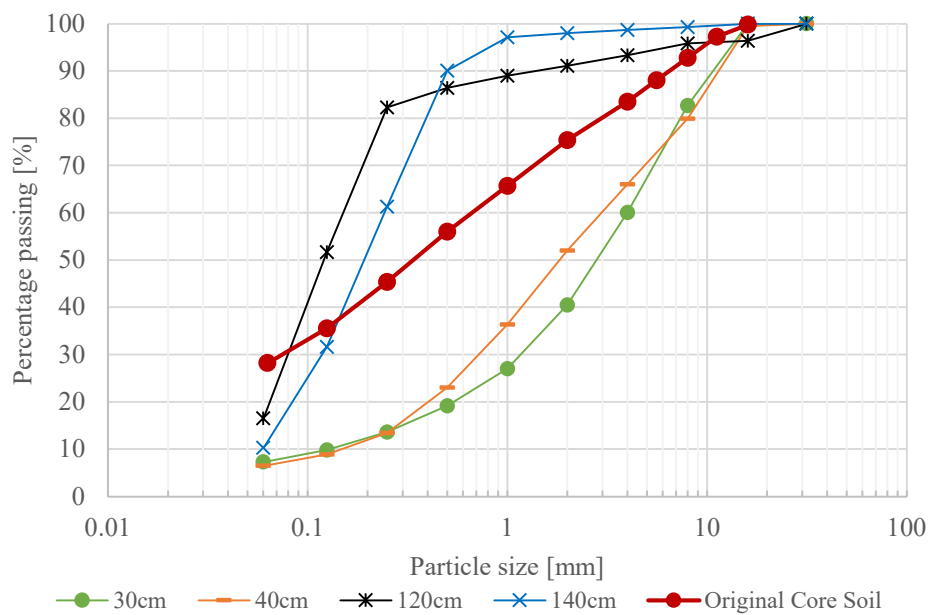
Figure 8. Particle size distribution curves show that eroded core soil sampled from higher parts in the sinkhole-like feature (140 and 120 cm above the base of the containment box) was more fine graded than eroded core soil near the bottom (40 to 30 cm). Fine material had been washed out in all locations compared with the original particle size distribution of the core soil (mean value from all tested core soil layers during construction), (Lagerlund and Riaz, 2026).

The way particles were sorted in the sinkhole, with coarse material at the bottom and fine particles at the top, matches what happens when water flow slows down during erosion. As seepage mobilizes core soil material, fine particles remain suspended longer and are thus transported further, while coarser grains settle earlier. This resulted in stratified deposit, with a coarse lag at the bottom and finer sediments accumulating above (Robbins *et al.*, 2020; Fell and Fry, 2007). This pattern has been documented in both field and laboratory studies. For example, sand boils formed during backward erosion piping often display similar grain-size stratification, with coarse particles near the vent and finer material deposited further away or higher up in a vertical profile (Robbins *et al.*, 2020). Hagerty (1991) also described how seepage-induced sapping and piping selectively remove fines, leaving behind coarser particles that can partially clog or stabilize erosion paths. The observed grain-size curves in Figure 8 align with these mechanisms, showing a clear decrease in particle size with elevation in the sinkhole fill.

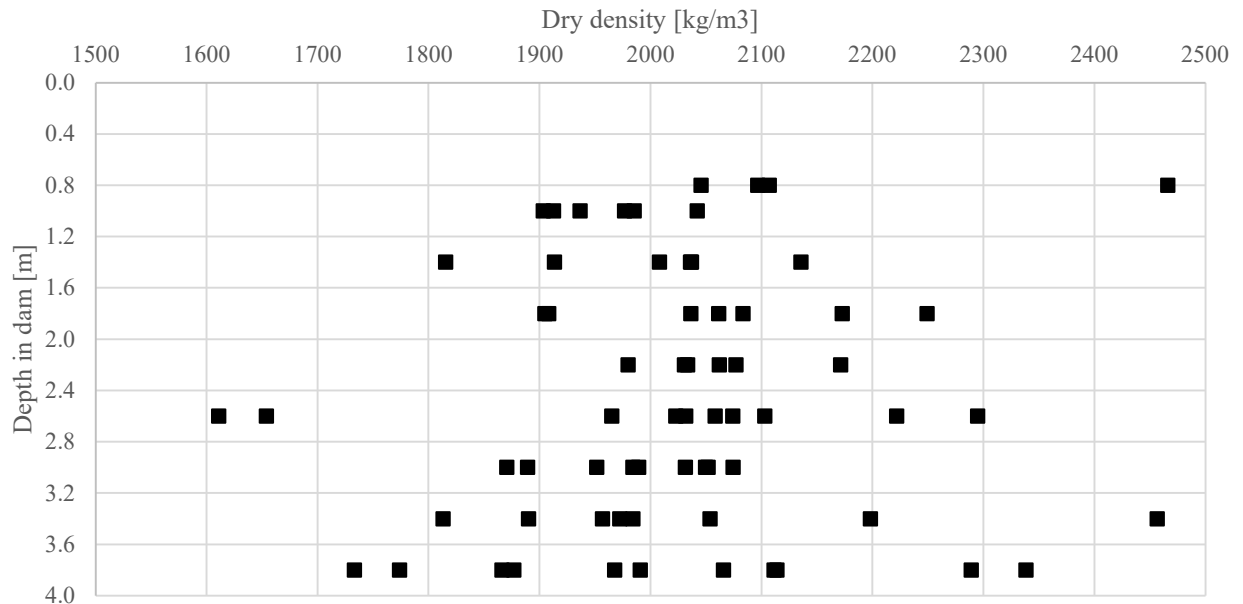
Dry density and water content tests performed at time of dismantling showed that *compaction quality varied in different parts of the core*, see Figure 13 and Figure 14.

Figure 13. Dry density of core soil from different depths measured during the in-situ density tests at time of dismantling. Note the extreme points  $> 2.2 \text{ t/m}^3$ .

- In some wet areas, the compaction was measured to be over 100% (optimum from testing prior to construction was  $2200 \text{ kg/m}^3$ ). The issue was found to be caused by soft core soil at the measurement site; when the water volumetric device was used, the soil caved in under its load. As a result, the volume of the

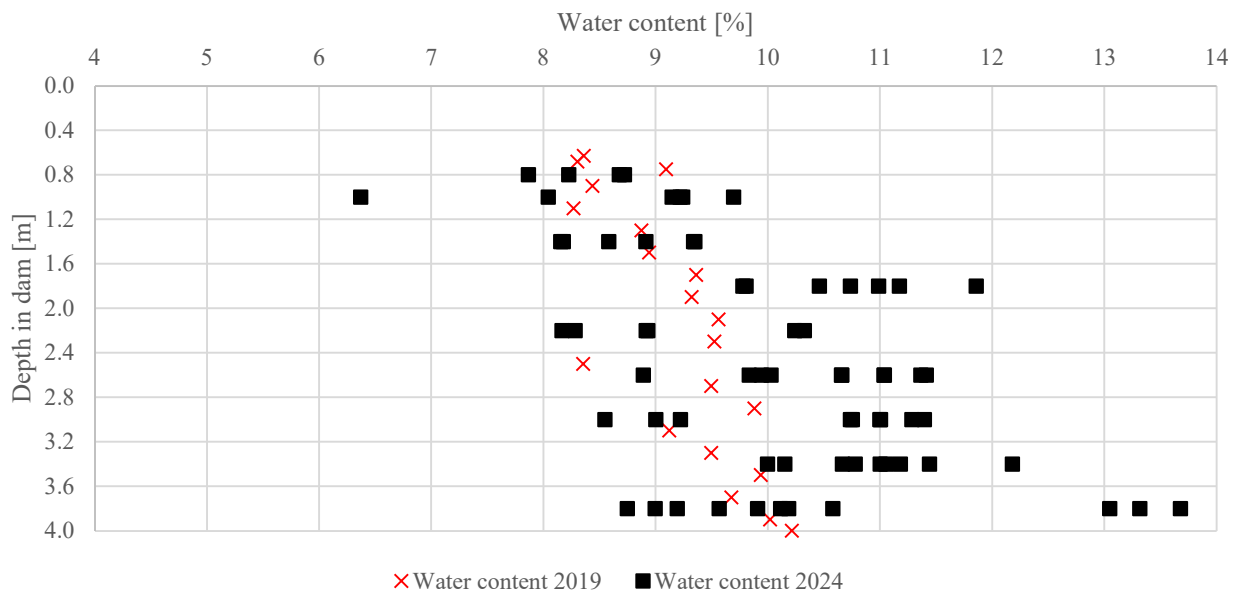
Figure 14. Water content of core soil from different depths measured during the in-situ density tests at time of dismantling. Water content at time of construction in 2019 was  $\sim 8 - 10.2\%$ .

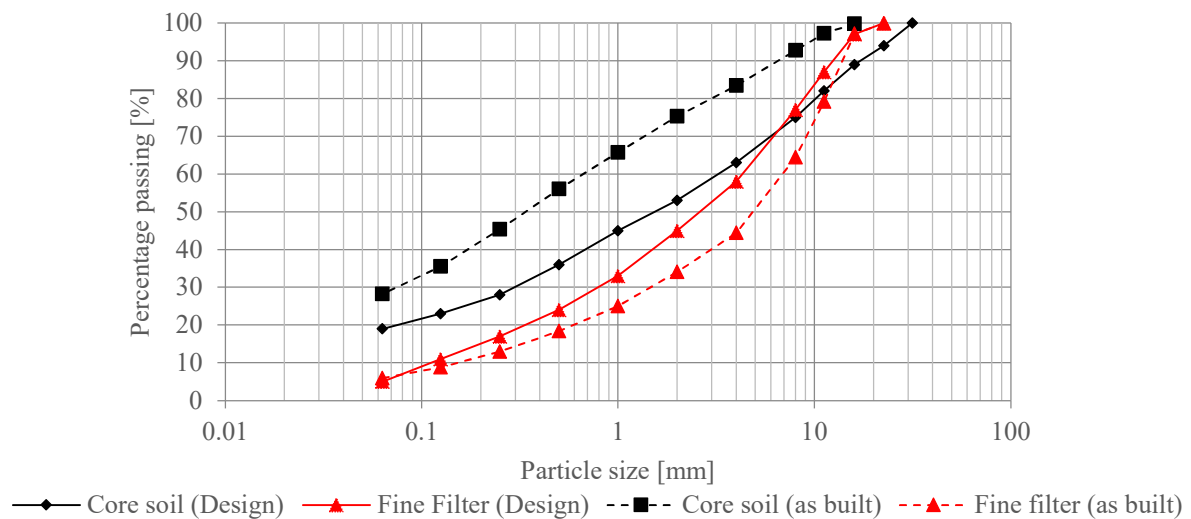
While Chrysikou (2025) identified levels 1.2 m and 2.4 m as critical due to filter–core incompatibility, the present analysis attributes the observed erosion more directly to construction-induced deviations. Specifically, the as-built fine filter was coarser than designed, and the core soil finer, reducing retention capacity, see Figure 16. Even filters nominally compliant with RIDAS (2012) criteria exhibited erosion, showing that just following the design is not enough without good quality checks during construction (RIDAS, 2020; Sherard *et al.*, 1984). Due to time constraints and lacking man power on site, proper reception control of received construction material, i.e., sieving, of delivered core soil and fine filter were done after the construction.

Figure 16. Core soil and fine filter particle size distribution at design and construction respectively.
