The Weakest Link

Degradation of a weld through interaction with hydrogen

Jonas Cop
Charlot Depestel
Nathalie Saikali
Sharon Temmerman
Dorien Zeebroek

Department of Materials, Textiles and
Chemical Engineering (MaTCh)
Faculty of Engineering and Architecture
Ghent University, BELGIUM
Kim.Verbeke@UGent.be

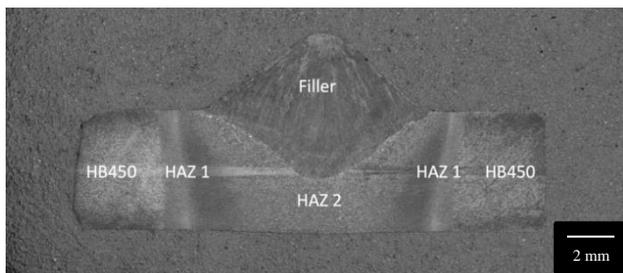
Figure 1 shows an optical micrograph of the weld and its heat affected zone (HAZ). Apart from the base material and the filler, two parts of heat affected zone were identified, i.e. HAZ 1 and HAZ 2.

Figure 1: LOM image of the weld of base material HB450 with filler and heat affected zones HAZ 1 and HAZ 2.

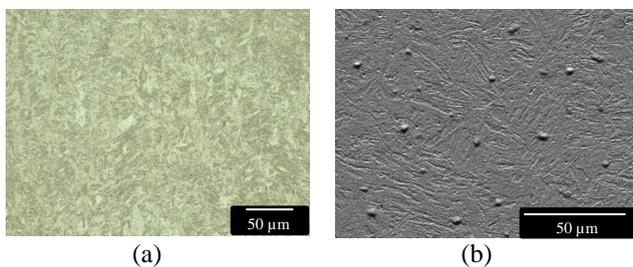
The microstructure of the base material HB450 can be seen in Figure 2. A fully martensitic material, indicated by a fine needle-like structure, was observed.

Figure 2: Representative images of HB450: (a) LOM, (b) SEM. Fully martensitic material with fine needle-like structure.

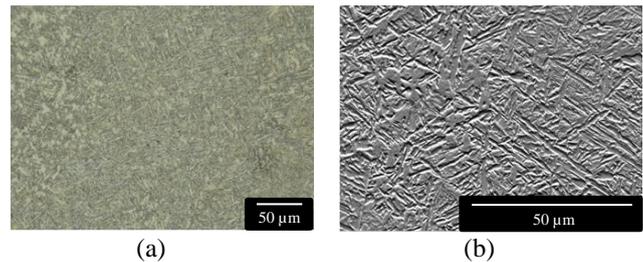
Representative images of the filler material are given in Figure 3. The chaotic structure and lenticular grains indicate the presence of acicular ferrite. During cooling down from the austenitic phase, these grains nucleated in different directions on inclusions present in the material. Due to its chaotic structure, there is a high amount of misorientation between the grains. This results in superior toughness, because of the decreased mobility of propagating cracks.

Figure 3: Representative images of the filler: (a) LOM, (b) SEM. Acicular ferritic microstructure.

The filler material was identified to be the softest phase of all different zones of the weld. This is in accordance with the observation of an acicular ferritic microstructure, as shown in Figure 3, compared to the (tempered) martensitic microstructures of the base material and heat affected zones.

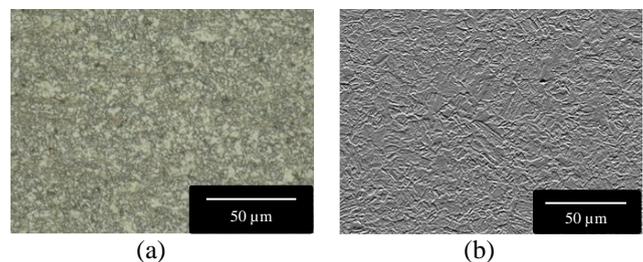
The heat affected zone consisted of two parts: HAZ 1 close to the base material HB450 and HAZ 2 close to the filler. The microstructure of HAZ 1, as shown in Figure 4, is most likely tempered martensite. The temperature was not sufficiently high to transform back to austenite, since HAZ 1 was relatively far from the filler material. This will be confirmed with hardness measurements in the next section. By contrast, HAZ 2 was heated into the austenitic range and transformed into martensite upon cooling down, as indicated by the coarse needle-like structure in Figure 5.

Figure 4: Representative images of HAZ 1: (a) LOM, (b) SEM. Tempered martensitic microstructure.

However, besides the hydrogen uptake and trapping capacity of a zone, also the hardness influences the material's behaviour towards hydrogen-induced damage. Therefore, a horizontal hardness profile was obtained, as can be seen in Figure 9. Starting from the base material, the hardness initially decreased when approaching the zone corresponding to HAZ 1. This is in accordance with the observation of a martensitic microstructure for HB450, as shown in Figure 2, and a tempered (and therefore less strong) martensitic microstructure of HAZ 1, visualized in Figure 4.

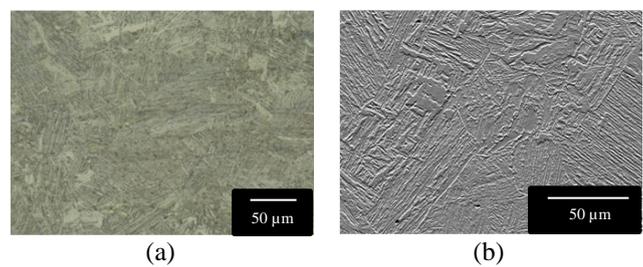
Figure 5: Representative images of HAZ 2: (a) LOM, (b) SEM. Coarse needle-like martensitic microstructure.

Closer to the weld, however, the hardness increased again in HAZ 2. In this zone, austenite (formed during welding) was transformed back into martensite upon cooling, as such resulting in a martensitic microstructure, as given in Figure 5. The hardness in the heat affected zone was still remarkably lower than in the base material since the cooling rate after welding was not controlled, as opposed to the cooling rate during initial production of the base material. During industrial production, the steel can be cooled significantly faster, resulting in a higher hardness of the martensite in the base material compared to HAZ 2. The higher hardness of HB450 with respect to HAZ 2 is in accordance with the observation of a fine needle-like martensitic microstructure for the base material compared to a coarse needle-like martensitic microstructure of HAZ 2, since in general a finer martensite lath thickness increases the material's hardness.
